Necessity and Suitability of In-Line Inspections for Corrosion Resistant Alloy (CRA) Clad Pipelines

ABSTRACT

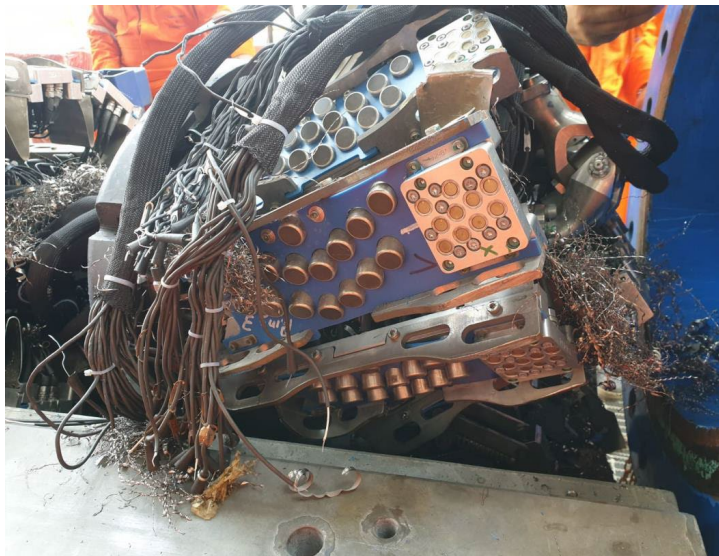
This paper outlines the necessity and suitability of subsea in-line inspections through an incident occurred to a corrosion resistant alloy (CRA) clad pipeline. In this incident, an ultrasonic pig tool was impacted and damaged the pipeline's CRA clad layer. Pressure surges were effective in dislodging the intelligent pigging tool, but they caused the pigs in the pigging train to collide with one another. The analysis of metal swarf recovered from the pig receiver revealed that the damage was limited to the CRA layer. The investigations revealed that the intelligent pig tool received a bypass after coming to a stop at 181m due to a combination of low pump rate and intelligent pig tool friction. As a result, the sealing pigs became entangled, damaging the sensor carrier of the intelligent pig tool and causing it to become stuck at the end of the pipeline.

Figure 1: Damaged ILI pig tool.

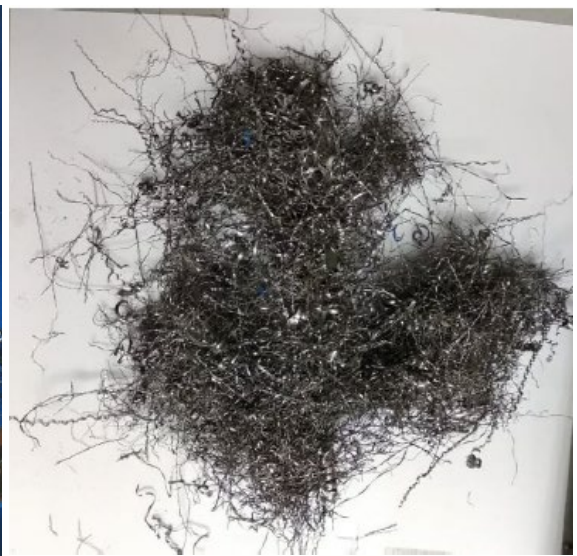
Figure 2: Metal swarf from pipeline.

Tungsten carbide is known for its high brittleness and excellent wear resistance. When the front edge of the protection layer is chipped, it peels off in an exponential fashion. When the layer is removed (for whatever reason), the skid only drives on the base material. To produce swarf like the one shown above, a geometrically defined and hardened cutting edge is required, as well as constant cutting forces throughout the process (e.g., machining metal in a turning machine); it is likely that a portion of the damaged ILI tool produced swarf like this one.

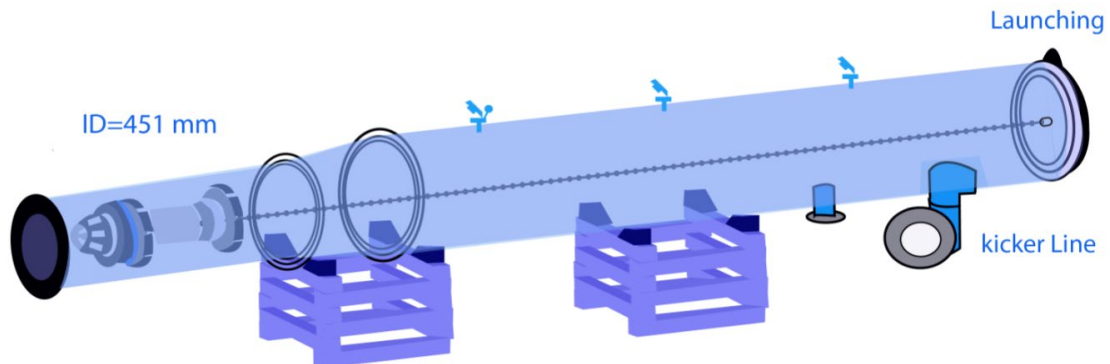
Figure 3: Layout of the blow-over test (showing the chain).

The result of a series of blow-over tests revealed that the blow-over pressure is dependent on the tow module's alignment with the pipe's centre. At a pressure of 5 bar, the cup did not flip over due to good alignment. The pressure was not increased further because the breaking load of the chain was about 6 bar. The lowest flip overpressure during the tests was 3.6 bar. The results can be summarized as follows:

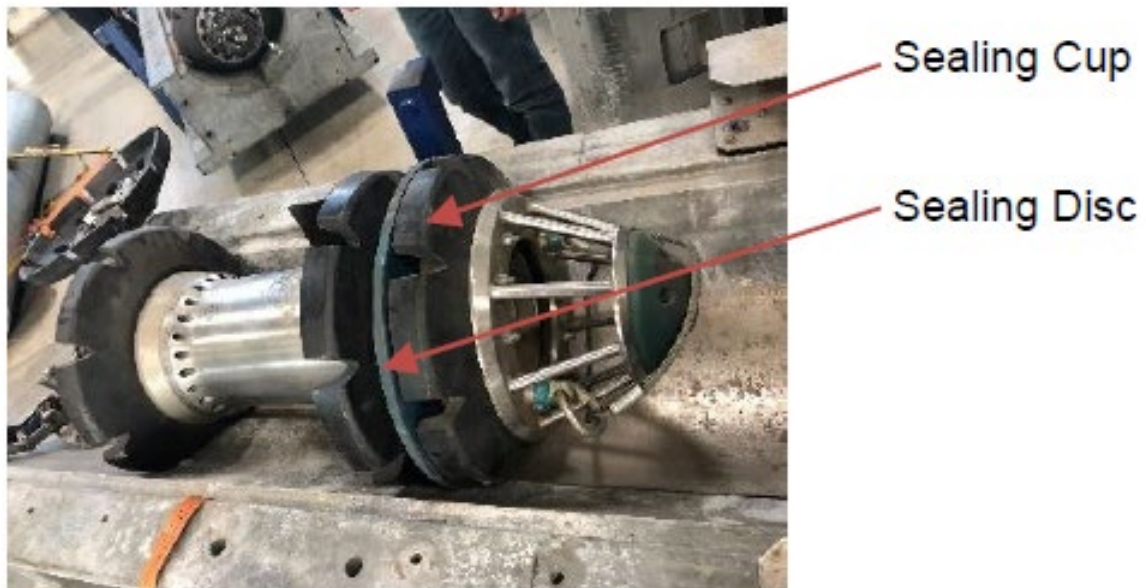
Figure 5 depicts the sealing mechanism. The sealing cup is made of polyurethane, and the sealing is accomplished by the sealing cup directly followed by a polyurethane sealing disc. When a certain amount of pressure is applied from behind, the cup cannot withstand the applied force and will flip over. When the cup is flipped over, the sealing becomes limited, resulting in a blow over of water from behind. The towing module was bypassed, but the flip overpressure was greater than the pressure required to move the ILI tool.

Figure 5: Towing module with sealing cup and sealing disc.

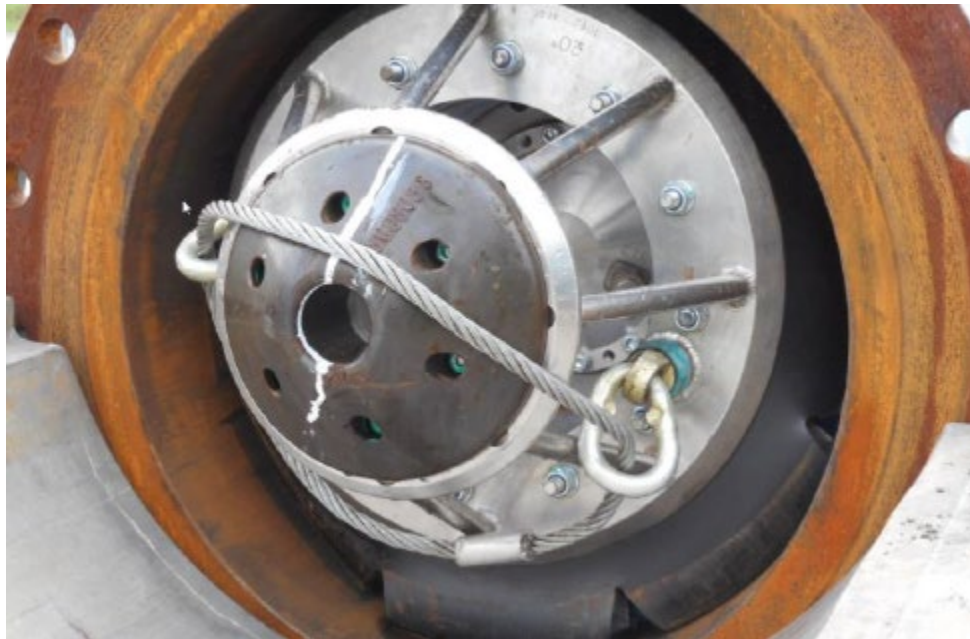
The first conclusion that can be derived from the tests is that because the pressure required to move the tow module was 0.5 bar, the required differential pressure to move the entire ILI tool must be greater than 0.5 bar. Given the number of cups and the sensor carrier, the required pressure is likely to be greater than 2 bar. Figure 6 depicts a realistic scenario of flipping over. The second conclusion is that it is possible to pump 60 m³/h across the flipped-over towing module, resulting in a differential pressure less than what is required to move the entire ILI tool.

Figure 6: Blown over the cup.

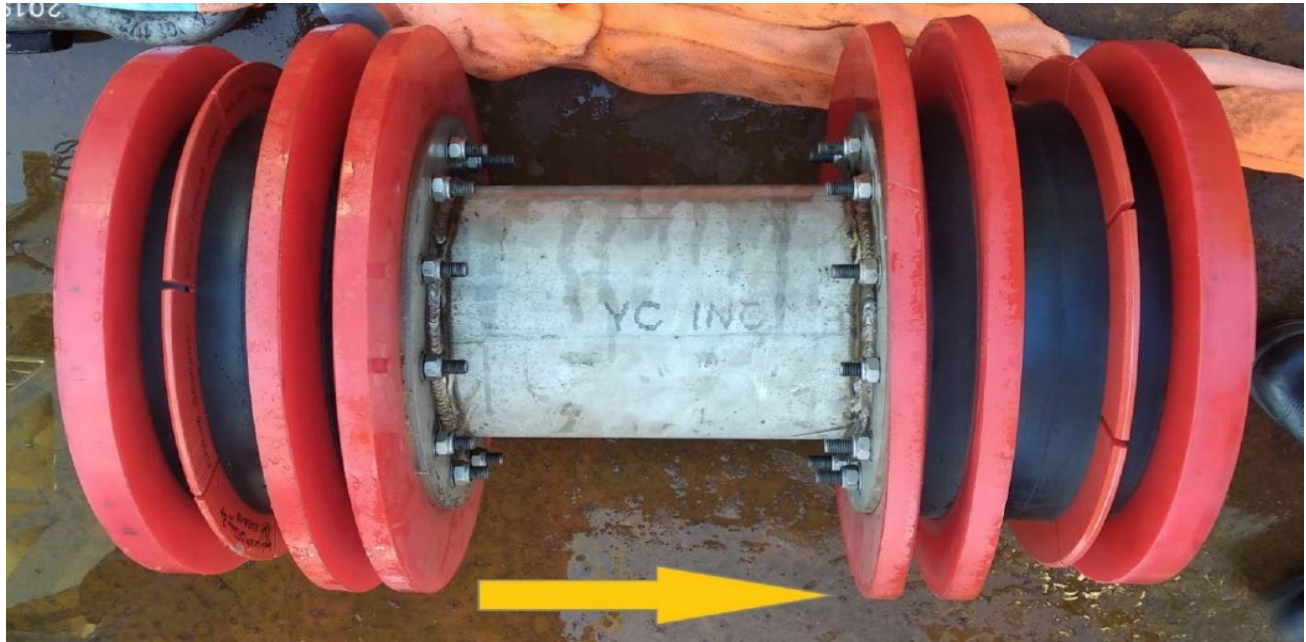
This section is based on the pressure diagram from the launcher side, log sheets and intelligent pig data. It should be noted that the pipeline was successfully cleaned and gauged prior to the unsuccessful ILI run, as shown in Figure 7, which shows the BiDi (Bi-directional) pig with the gauge plates used prior to the unsuccessful ILI run. As can be seen, there are no signs of damage.

Figure 7: Setup picture for gauge run before unsuccessful ILI run.

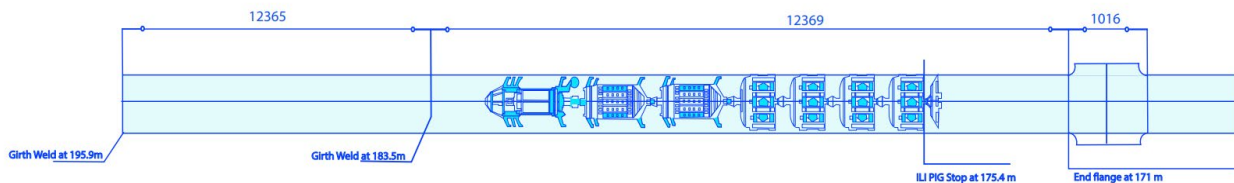
Figure 8 shows the position of the intelligent pig when stopped at 12:48 in a straight section of the pipeline resting on a flat seabed without contact with flanges or girth welds. The tow module of the intelligent pig stopped at 181 m, which was measured relative to the pig launcher. The last sensor carrier of the intelligent pig was 175.4 m away from the pig launcher. The pig launcher was 171.2 m away from the end of the pipeline flange and the on-mating flange on the tie-in spool.

Figure 8: Position of the intelligent pig at 181 m.

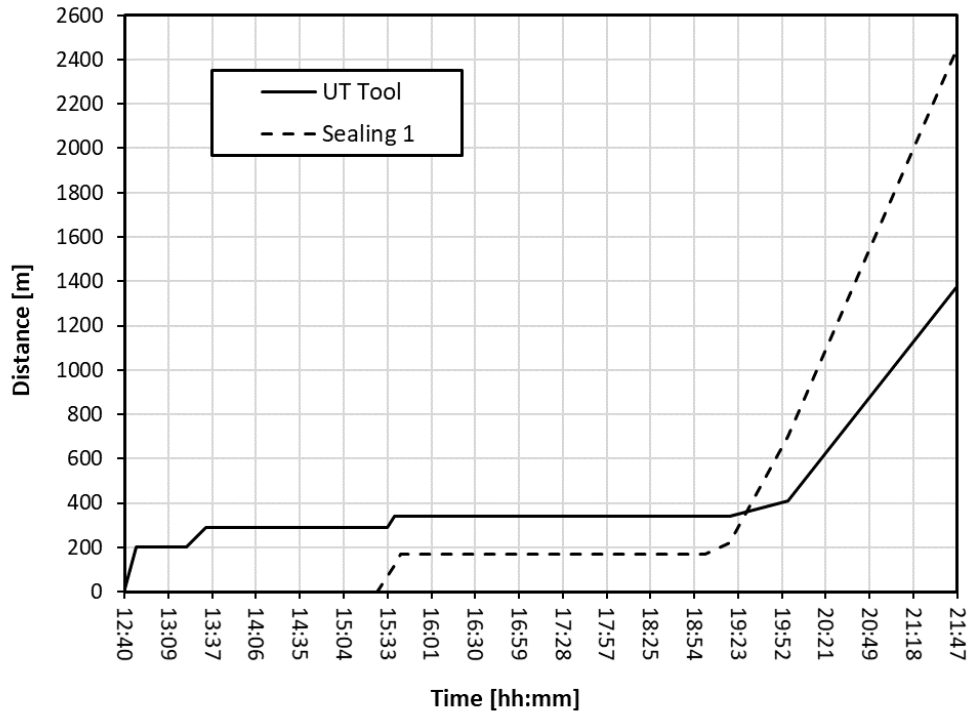
Figure 9 shows the distance between the UT intelligent pig (solid black) and the 1st sealing pig (dotted black line) in relation to time. The graph for the 1st sealing pig was created from the flow data and readings from the pump log sheets. The dotted black line shows the distance of the 1st sealing pig assuming the absence of the bypass. The 1st sealing pig was launched at 15:30, and at the time of launch, the distance between the 1st sealing and the UT intelligent pig was 277 m. It is indicated that the 1st sealing pig caught up to the ILI tool at 19:56, followed by an acceleration (as shown on the retrieved data from the log events for sensors). It should be noted that the speed of the 1st sealing pig was based on theoretical calculations. In the actual situation, the sealing pig may have experienced some bypass. Hence, the theoretical calculations may have some variation. The theoretical calculations of the 1st sealing correlate to the previous assumption that the 1st sealing pig hit the intelligent pig at 19:45 (400.61 m). The 60% level of bypass should not normally be possible and does not reflect earlier test results. This level of the bypass would only be possible due to a failure in the sealing elements or position, and any conclusion on this can only be determined from the planned sealing tests.

Figure 9: Path-time diagram of intelligent pig and 1st sealing pig.

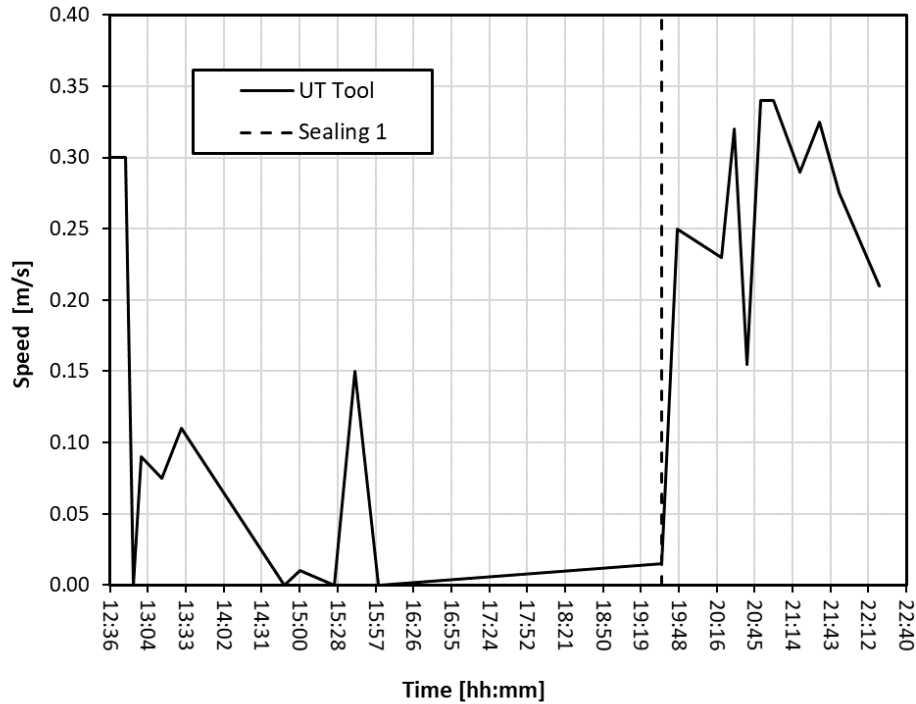
Based on the time and flow readings from the receiver log sheet, the pumped speed versus time was calculated and visualized in Figure 10. It starts with the launch of the ILI tool at 12:40 and ends when 100% of pipeline volume is completed. It can be seen that the flow during the first 181 m is at the required 0.30-0.35 m/s. From the time of the unplanned pump stop to the beginning of nitrogen injection, the flow rate was too low, thus preventing the ILI tool from moving. At 19:00, the injection of nitrogen began and the flow rate was increased at 19:47 and was at the required value of 0.3 m/s.

Figure 1: Speed chart based on pumped volume.

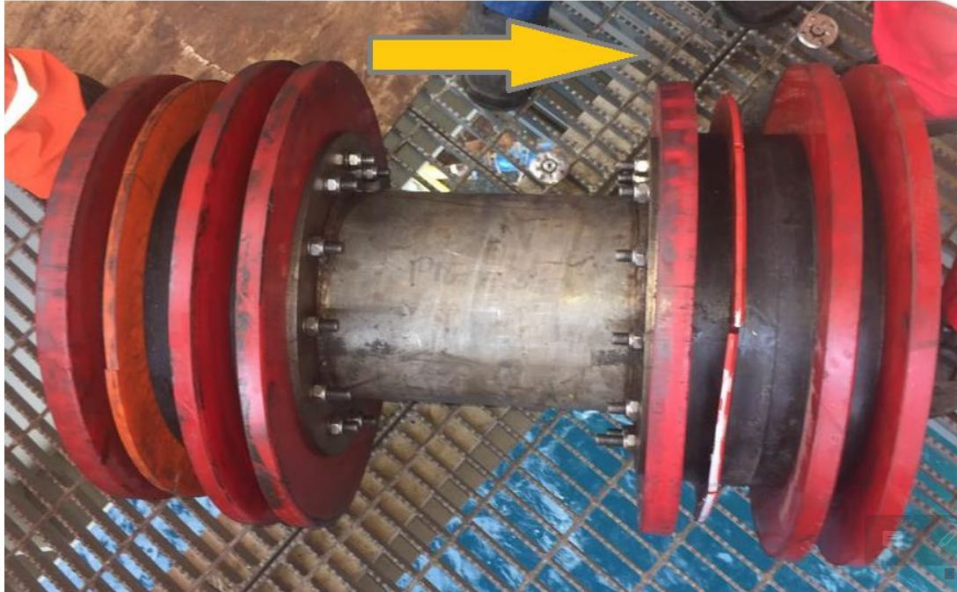
Following the failure of the ILI run, a cleaning train was launched. The setup was as follows: 50m³ water/foam (Pig #1), 30 m³ water/BiDi with brushes (Pig #2), 30m³ water/BiDi with brushes (Pig #3), 30m³ water/BiDi with gauge plates (437 + 424 mm) (Pig #4)/N₂. The gauge plates attached to Pig #4, as shown in Figure 11, had scratches and were damaged, with one segment deformed. Impaction at pipe bends caused by rapid depressurization (i.e., uncontrolled pressure release and opening and closing of discharge valves) was the cause of the damage. The nitrogen/water mix was received in front of Pig #3, and the pressure suddenly increased to 8 bar during receiving of Pig #3. The same jerk/impact is expected to have occurred with Pig #3, and as a result of the impact, the magnet securing screws became separated from the magnet covers. In front of Pig #4, all magnet retaining screws were counted. A close examination revealed that one of the magnet covers was damaged. The results of the cleaning runs were taken into account for a possible future ILI re-run. Because all lost parts (i.e., magnets) were collected, as well as a minor amount of swarf and FBE coating, it was assumed that the pipeline had been cleaned of any debris and other residue.

Figure 2: Picture after gauge run (after ILI run).
