## Development of ROV system to explore fuel debris in the Fukushima Daiichi Nuclear Power Plant

Instruments and Methods were developed to explore fuel debris at the bottom of the Primary Containment Vessel in the Fukushima Daiichi Nuclear Power Plant. A Remotely Operated Vehicle was designed to explore fuel debris and to investigate the distribution and surface profile of fuel debris at the bottom of the primary containment vessel using a sonar and a compact radiation detector. Several tests were carried out using various facilities to determine the capabilities of the sonar and gamma-ray detector to determine the feasibility of the device.

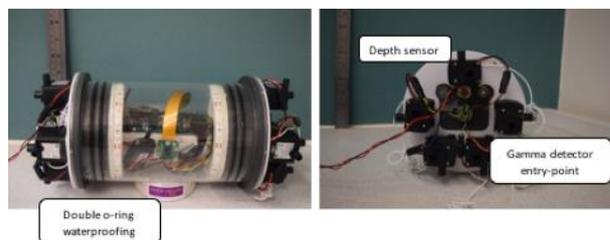
The Remotely Operated Vehicle (ROV) designed in this study was developed by the University of Manchester to explore fuel debris at the bottom of the PCV and is named the Aqua Vehicle Explorer for In-situ Sensing (AVEXIS). **Figure 1** shows a picture of the AVEXIS [1]. The AVEXIS is cylindrical in shape with a diameter of 150 mm and a length of 347 mm. It has 5

thrusters on each end-cap that provide movements forwards, backwards, left, right, up, and down as shown in the right of Figure 1. Two O rings were attached on each end cap to seal the AVEXIS and make it watertight to up to 100 m depth.

Figure 1. Picture of the AVEXIS, left picture and right picture show front and end of the AVEXIS.

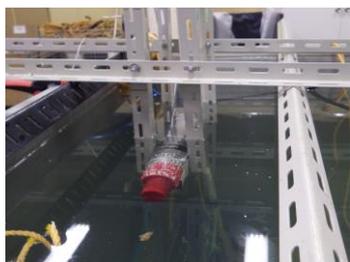
The sonar system is able to investigate the distribution and surface profile of fuel debris at the bottom of the PCV in any transparency under the submergible environment in the PCV without being affected by the radiation. Sonar was a rotating-beam sonar 831L [3] with a size of 61 mm in diameter and 343 mm in length by IMGEX Technology Corp., Canada as shown in **Figure 2**. The frequency of the 831L is 2.25 MHz .

Figure 2. The sonar used in this study was the 831L rotating-beam sonar.

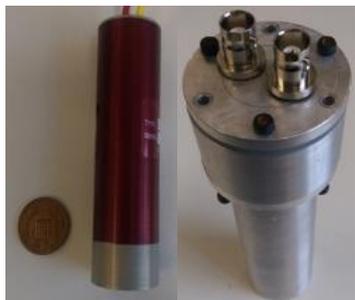
such as  $^{154}\text{Eu}$ ,  $^{60}\text{Co}$ , and  $^{144}\text{Ce}(^{144}\text{Pr})$ . The  $\text{CeBr}_3$  inorganic scintillator [2] was used as a photon detector accommodated into the AVEXIS, because the  $\text{CeBr}_3$  scintillator has higher sensitivity and energy- resolution to gamma rays than those of the well-established  $\text{NaI}(\text{Tl})$  scintillator. The  $\text{CeBr}_3$  scintillator was 10 mm in diameter and 10 mm in length and in this study was coupled to a photomultiplier R9880-10 by Hamamatsu Photonics K.K. and covered with an Aluminum housing as shown in **Figure 3**.

Figure 3. The  $\text{CeBr}_3$  inorganic detector without and with aluminum casing.

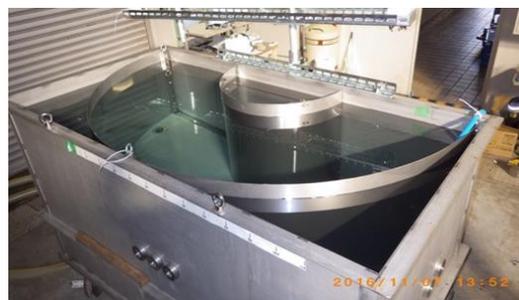
Two sizes of tank were used to characterize the noise from multi-pass propagation created by the multiple reflections, and produced the mockup PCV with an actual scale of 1/6 to inspect the correlation of the reflections and the shape of the wall and the floor of PCV. **Figure 4** shows the mockup of PCV inside a smaller tank. This tank has a dimension of 2 m x 1 m x 1 m in depth, and a larger round tank with a diameter 6 m and a depth of 10 m as shown in **Figure 5**. Moreover, in order to characterize the image resolution of the surface profiling of the fuel debris, two types of test pieces for the fuel debris were provided. One was simulated fuel debris made of copper alloy to identify

Figure 4. The small tank with the mockup of the PCV.

In the smaller tank test, the mockup of PCV was also used at the same time, and the model debris was scanned by moving the sonar along the wall.

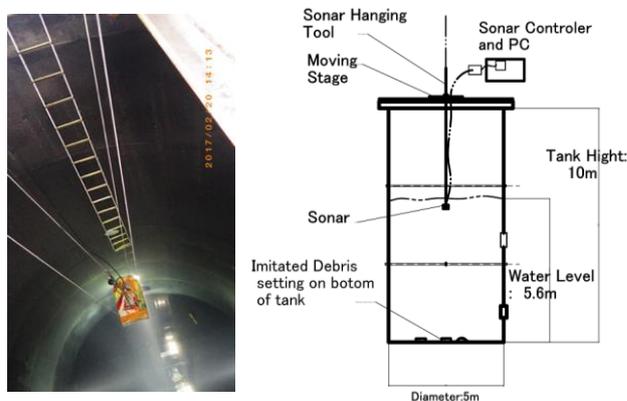
Figure 5. Large round tank.

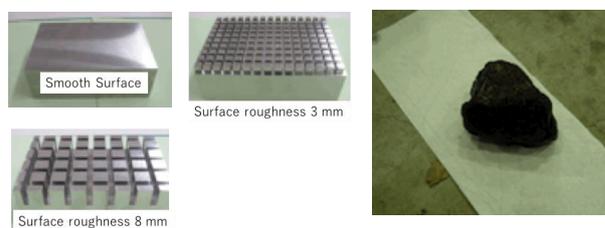
the debris profile as shown in **Figure 6**, and the others were stainless steel block with three sizes of roughness, 0 mm, 3 mm, and 8 mm as shown in **Figure 7**. A rock was also used to confirm the surface status.

Figure 7. Stainless steel block with roughness and the rock.

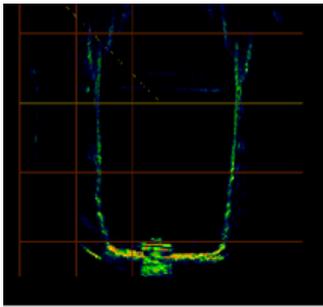
The 831L was able to identify the test pieces of fuel debris in the small tank test as shown in **Figure 8**, although the ghost due to the reflected wave from water surface was contained in the sonar image. The images by scanning the three stainless steel blocks with a roughness of 8 mm, the rock with a diameter of about 12 cm, and the profile simulated fuel debris are shown in **Figures 8, 9** and **10**. These figures indicate that the 831L sonar can distinguish ditches of the stainless steel block as shown in **Figures 8, 9**. The image by the 831L sonar inside the mock-up of PCV in the small tank shows clearly the profile of the simulated fuel debris in spite of the noises from the multi pass propagations being mixed into the sonar image as shown in **Figure 10**.

Figure 8. Image of the stainless steel block.

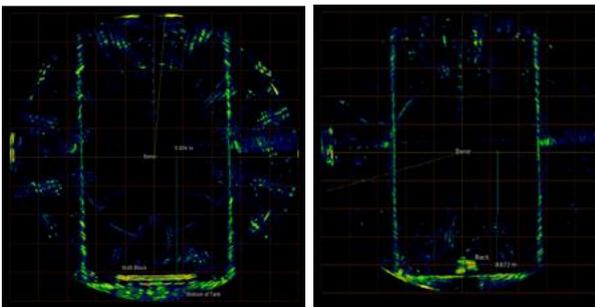
Figure 9. Images of the stainless steel block(left) and the rock(right).

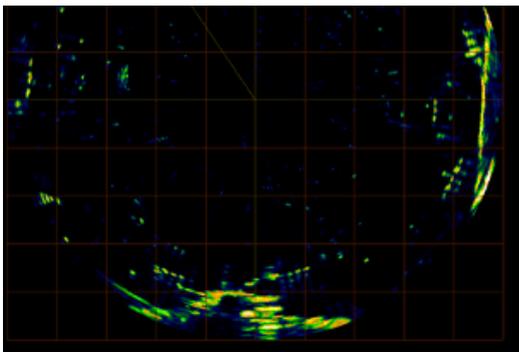
Figure 10. Image of the simulated fuel debris.

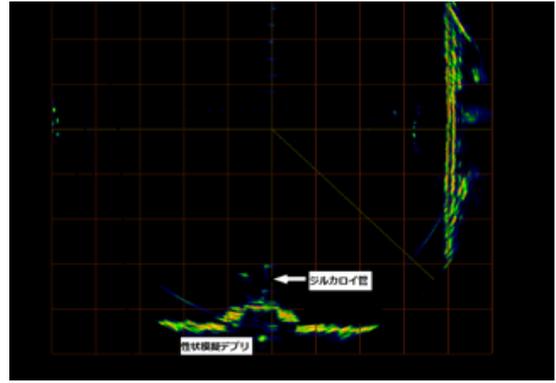
Figure 11. Image of the simulated debris with noise absorber on the wall.

The image by scanning the simulated fuel debris with the 831L sonar shows clearly the profile of debris including the Zircaloy pipe as shown in **Figure 11**.

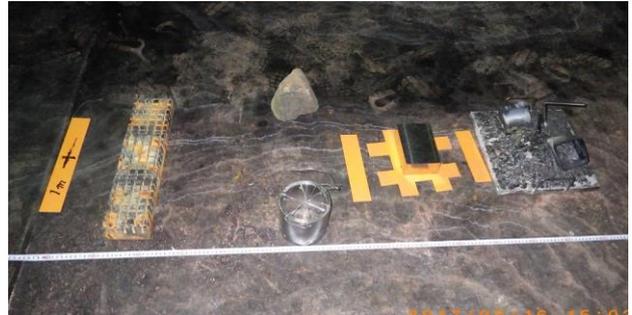
The test in the large round( $\phi 5\text{m}$ ) tank, for exploring the test-pieces of fuel debris as shown in **Figure 12**, was carried out by moving the sonar straightforward. The distance between the sonar and the model debris was about 5.5 m. Noise from the multi path propagations was not observed, but the test-pieces of fuel debris could be identified as shown in **Figure 13**.

Figure 12. Model debris

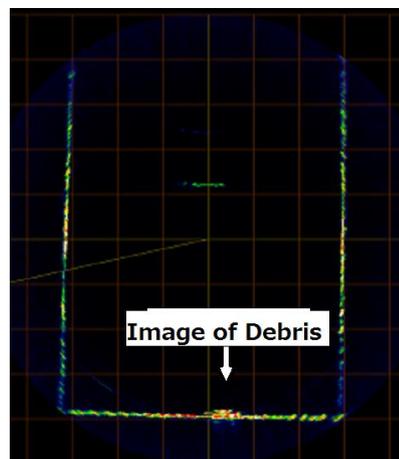
Figure 13. Image of the simulated fuel debris on the bottom of the large tank.

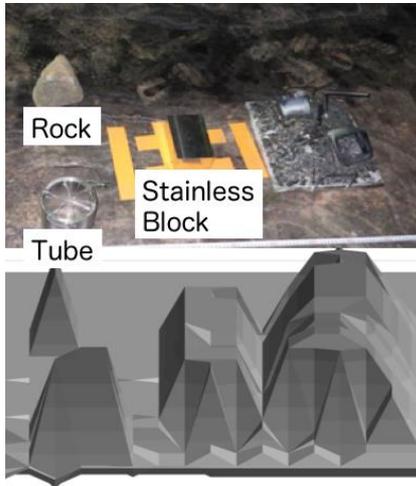
From the tank test, the 831L sonar was preferable to the sonar system accommodated in the AVEXIS. **Figure 14** shows a 3D image reconstructed by the 831L sonar data. The simulated debris in the upper picture corresponds to the illustration in the lower picture.

Figure 14. The 3D image reconstructed by the 831L sonar data.

The 3D image could be reconstructed by 831L sonar data. In the future, neutron dose from fuel debris may be evaluated by converting from 3D image of sonar output at the time of exploration into geometrical input of a dose evaluation system in PCV.

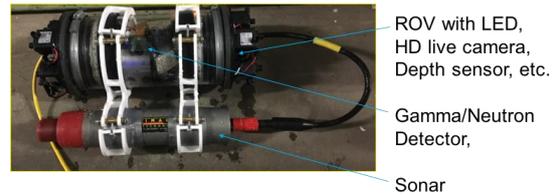
The 831L sonar was incorporated into the AVEXIS as shown in **Figure 15**. The communication between the 831L sonar and the AVEXIS and the power supply were achieved using a power over Ethernet cable. The operation with the 831L sonar in the large tank was no problem.

Figure 15. Integration of the 831L sonar into the AVEXIS.
