1 **First evidence of widespread, severe soil erosion underneath centre-pivot**  
2 **irrigation systems**

11 Centre-pivot systems are widely used for irrigation in agriculture. However, excessive  
12 water application rates under low pressure centre-pivot systems can lead to soil  
13 erosion, which degrades soil structure and increases crop vulnerability to droughts.  
14 Although efforts have been deployed to measure soil erosion underneath individual  
15 centre-pivots, a large-scale systematic assessment of extent and severity of soil  
16 erosion in centre-pivot irrigated fields is currently lacking. Here we used Google  
17 Earth™ satellite images to provide first evidence of widespread, severe soil erosion  
18 in centre-pivot irrigated agricultural land. We focused on the municipality of Cristalina  
19 (6154 km<sup>2</sup>), in the Brazilian Central Highlands, where centre-pivots irrigate  
20 approximately 60 000 ha of cropland. The study area is in the Cerrado biome, which  
21 is one of the most important grain-producing regions in the world and Brazil's main

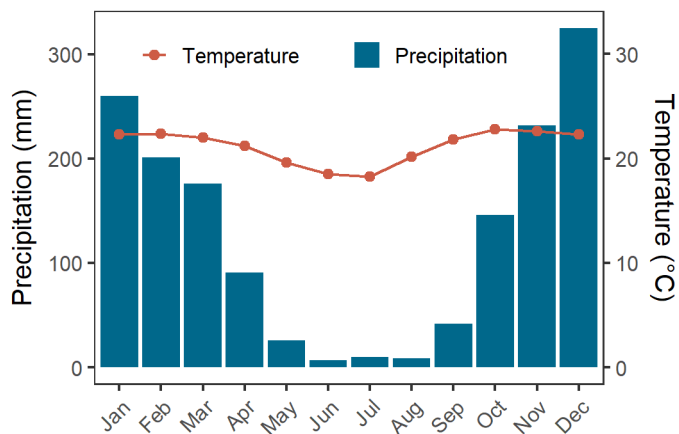
118 Figure 2. Long-term average monthly temperature and rainfall (1950-1990) for the  
 119 municipality of Cristalina, Brazil. Data from Alvares et al. (2013).

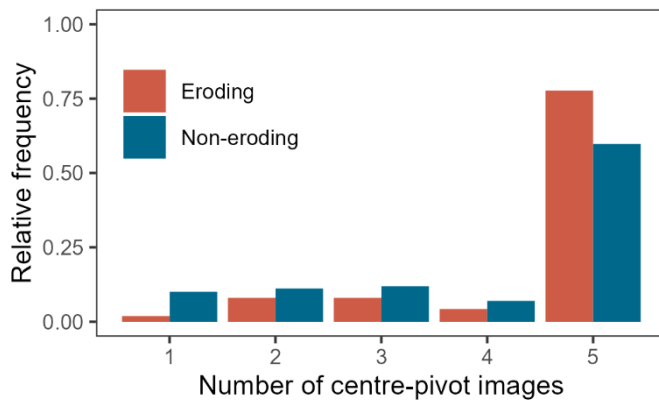
246 Figure 5. Relative frequency (0 – 1) of the number of GE images per centre-pivot field  
 247 for eroding and non-eroding fields.

233 According to the matching classifications, 211 centre-pivot fields displayed signs of  
234 rill erosion, which corresponded to 29% of 738 analysed fields (Figure 4). The  
235 eroding centre-pivot fields were more likely to be identified when a larger number of  
236 images from different timepoints were available (Figure 5). This highlights the

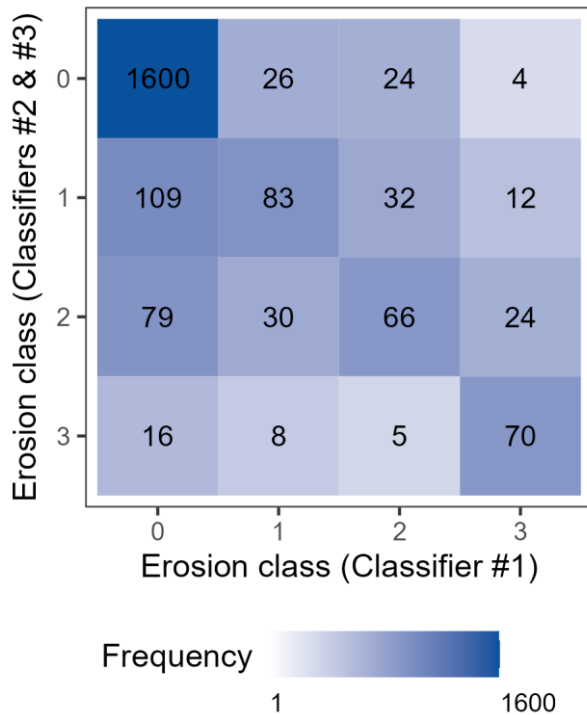
260 Figure 6. Confusion matrix for the erosion-feature classes assigned by Classifier #1  
 261 and Classifiers #2 and #3 for the centre-pivot-field images. Numbers in the boxes  
 262 refer to the frequency of erosion classes assigned by the classifiers.

248 If we considered only the 2188 centre-pivot-field images with matching image dates,  
 249 it was clear that the disagreements between classifiers were mostly associated to the  
 250 assignment of neighbouring categories (Cohen's kappa = 0.53; RMSD = 0.24)  
 251 (Figure 6). This pattern was particularly evident for erosion classes 1 and 2, which  
 252 displayed the lowest classification agreement (74% and 72%, respectively). The  
 253 discrepancies in these classes were expected, as the identification of smaller rills is  
 254 error prone. Moreover, distinguishing what constitutes a legacy rill, compared to an  
 255 actively eroding one, is partially subjective. Nevertheless, Classifier #1 assigned a  
 256 greater proportion of eroding centre-pivot images to Class 3 (29%) and a lesser  
 257 proportion to Classes 1 and 2 (38% and 33%, respectively), compared to Classifiers  
 258 #2 and #3 (Class 1 = 44%, Class 2 = 37%, Class 3 = 19%) (Figure 6).

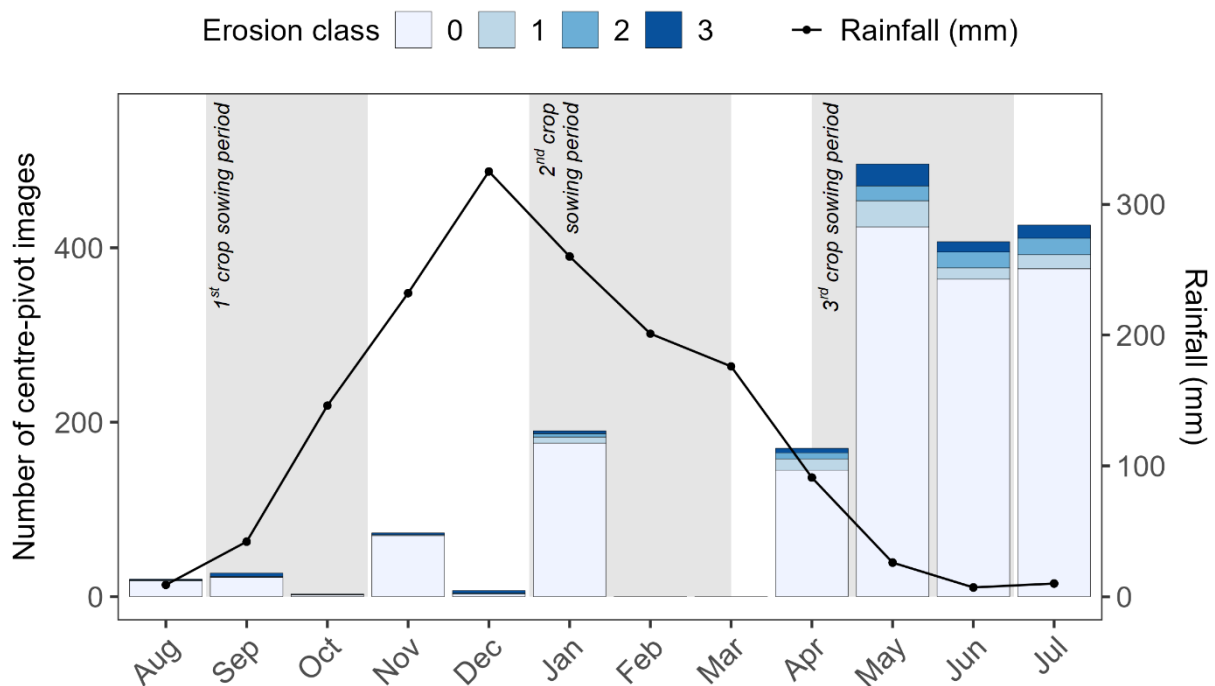
283 Figure 7. Number of analysed centre-pivot fields according to the month of the year  
 284 of the GE images. Rainfall data from Alvares et al. (2013).

273 Most erosion features were identified during the dry season of the Brazilian Cerrado,  
 274 using images from May, June, and July (Figure 7). This was related to the greater  
 275 availability of GE images with low cloud cover during this period of the year. Erosion  
 276 features were identified in more than one image for 52% of the centre-pivot fields.  
 277 This frequent identification of active, severe signs of rill erosion during periods with  
 278 very low rainfall indicates that centre-pivot irrigation might be either aggravating or  
 279 initiating soil erosion. As argued by Boardman and Evans (2020), the timing of  
 280 erosion monitoring is critical, as erosion signs are easily be masked by vegetation –  
 281 particularly in the humid tropics.

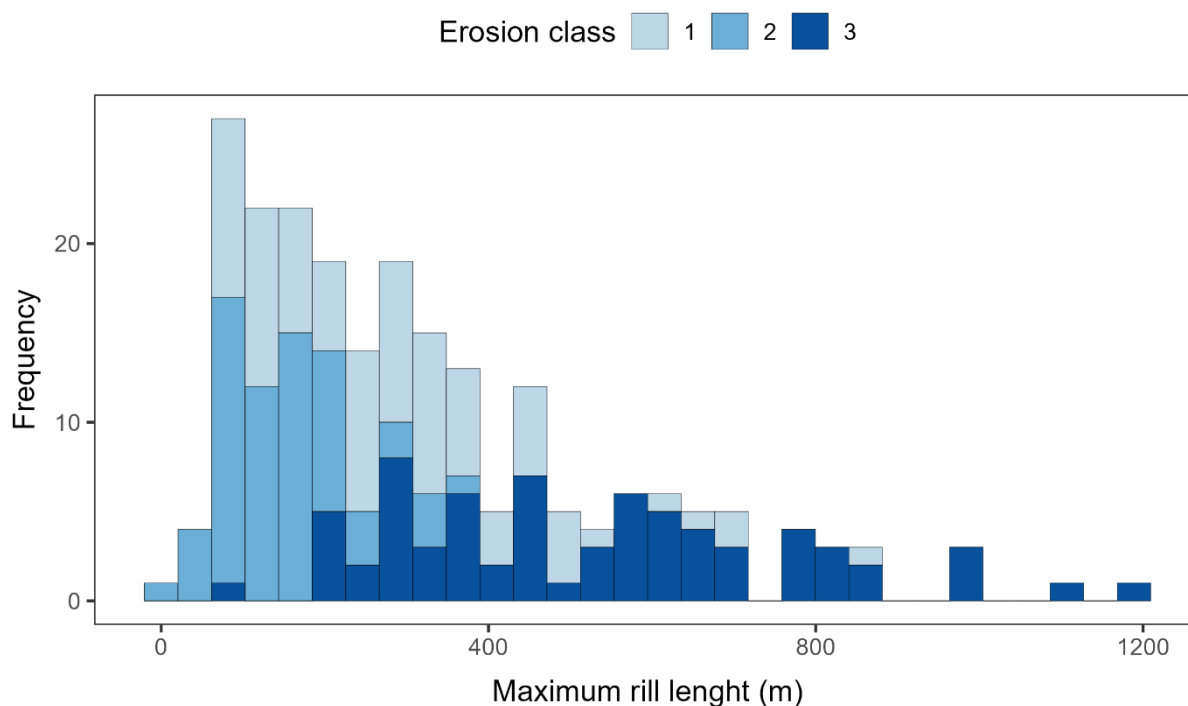
334  
335 Figure 9. Stacked histogram of the longest rill lengths per centre-pivot field observed  
336 in the GE images for irrigated areas in Cristalina, Brazil.

319 The median length of the longest rill per centre-pivot image was 260 m (interquartile  
320 range = 151 – 440 m), with a maximum value over 1200 m (Figure 9). These rill  
321 lengths are some of the longest described in the scientific literature and exceed those  
322 found in Boardman (2016), Fischer et al. (2018), Prasuhn (2020), and Van Oost et al.  
323 (2005). Rills underneath centre-pivots in Cristalina appear commensurate to gully  
324 networks, such as those developed in olive orchards in Spain (Castillo et al., 2012).

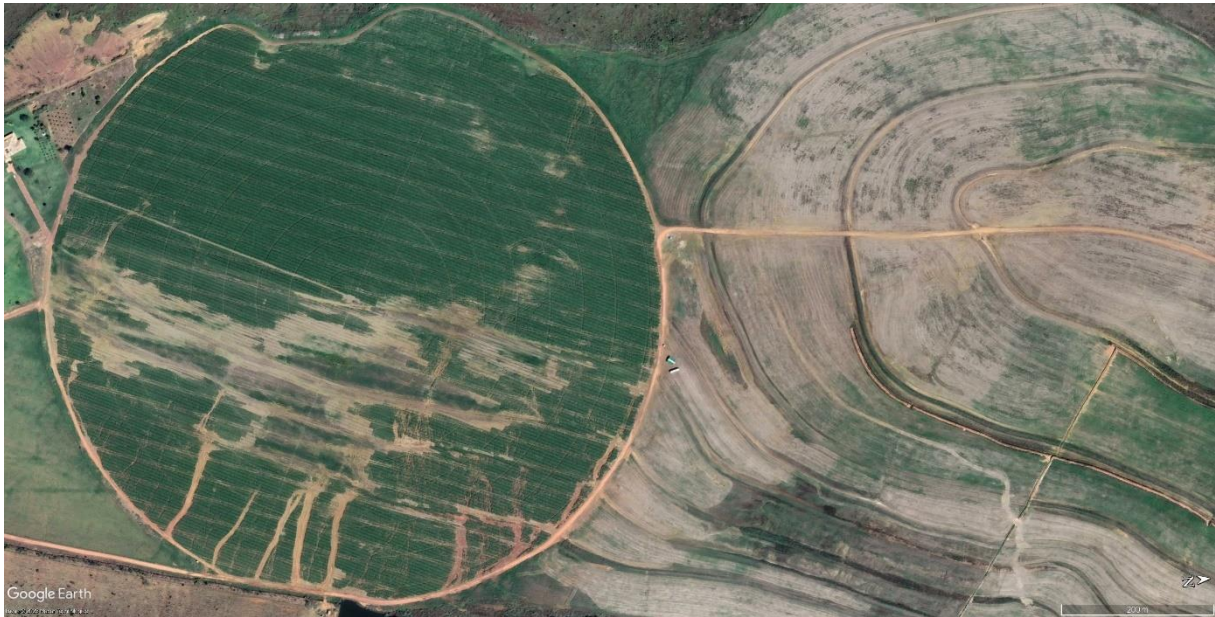
338 Figure 10. Severe signs of soil erosion over a large proportion of the centre-pivot field  
339 (Pivot ID 11508, diameter = 800 m), compromising crop yields in the affected area  
340 (about 30% of the field) (May 2020). Adjacent rainfed, terraced cropland on the right  
341 side of the image does not show similar erosional features. Imagery from Google  
342 Earth™.

325 In some cases, the centre-pivot images illustrate widespread signs of soil erosion  
326 over a large proportion of the field, significantly impacting on crop production (Figure  
327 10).

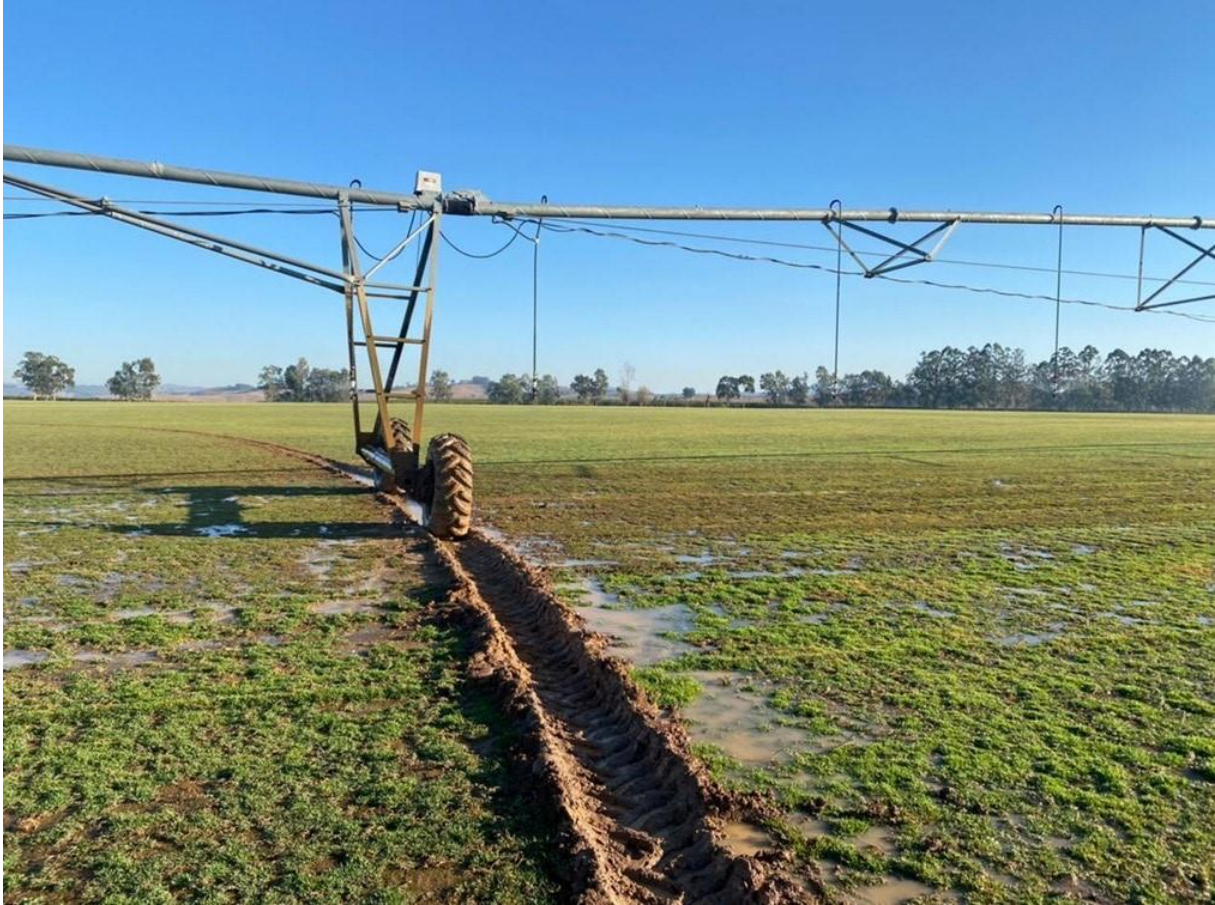
377 Figure 12. A centre-pivot wheel creating a compacted track as it moves over wet soil  
378 with surface ponding in Macaia, Minas Gerais, Brazil. Photo from Victor B. S.  
379 Baptista.

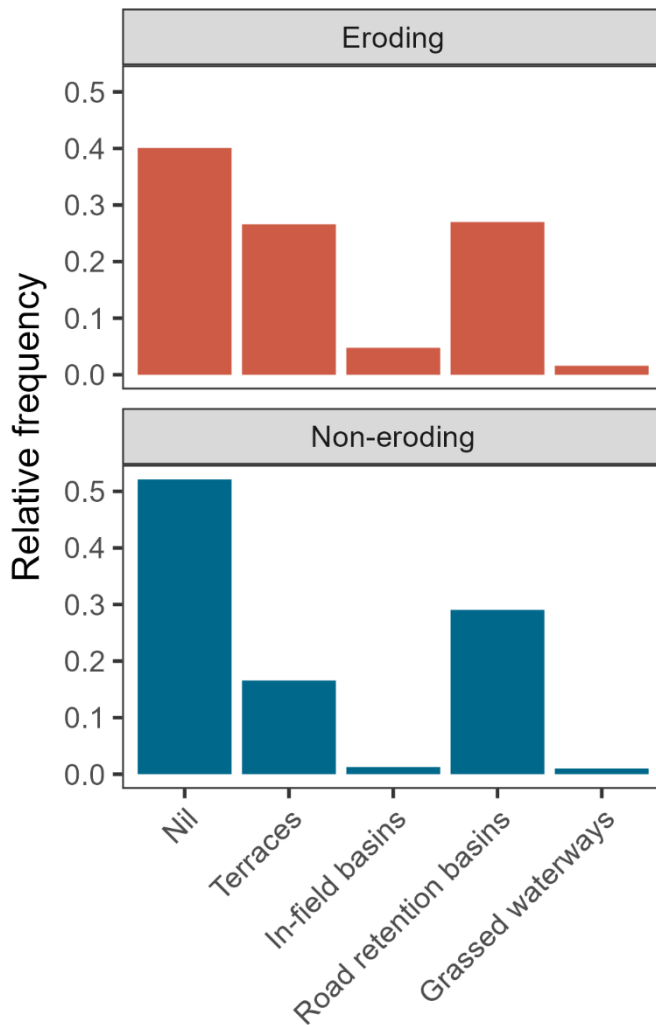
402 Figure 14. Relative frequency (0 – 1) of soil conservation and offsite pollution-control  
 403 structures observed in centre-pivot fields in Cristalina, Brazil.

393 The main soil conservation and offsite pollution control structures currently employed  
 394 in the centre-pivot fields were retention basins and broad-based terraces (Figure 14).  
 395 Of note is that soil conservation practices, particularly terracing, were more frequently  
 396 identified in the eroding centre-pivot fields, compared to the non-eroding (Figure 14).  
 397 This is possibly the result of terraces being established as a means to counteract soil  
 398 erosion, rather than preventing it. However, improvised terraces (i.e., not properly
