# SR613\_Analysis and suggested modifications for Queen Scallop dredge net\_C100

## **West Coast Sea Products Ltd**

# **Analysis and suggested modifications for Queen Scallop dredge net**

**October 2008**

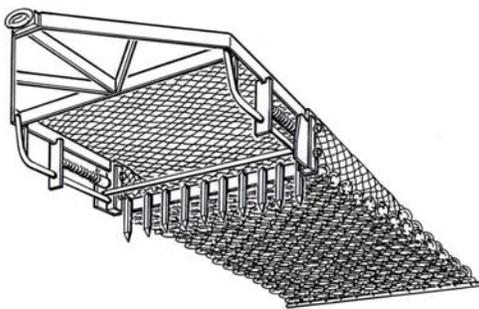
Figure 1: Spike dredge

Currently, scallops are collected by dragging a series of metal nets along the sea bed (Fig.3). A series of metal spikes or “tickler” chains at the front of the net flip the scallops out of the sand and into the net (see Fig.1 and Fig. 2)). This method has several very large drawbacks as follows:

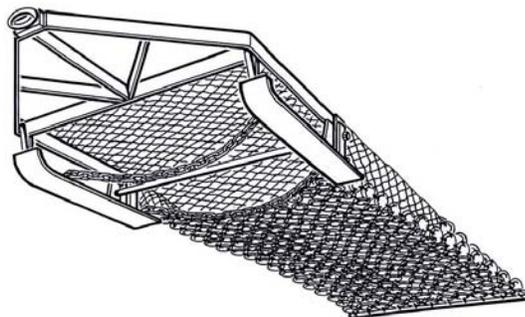
Figure2: Bar dredge

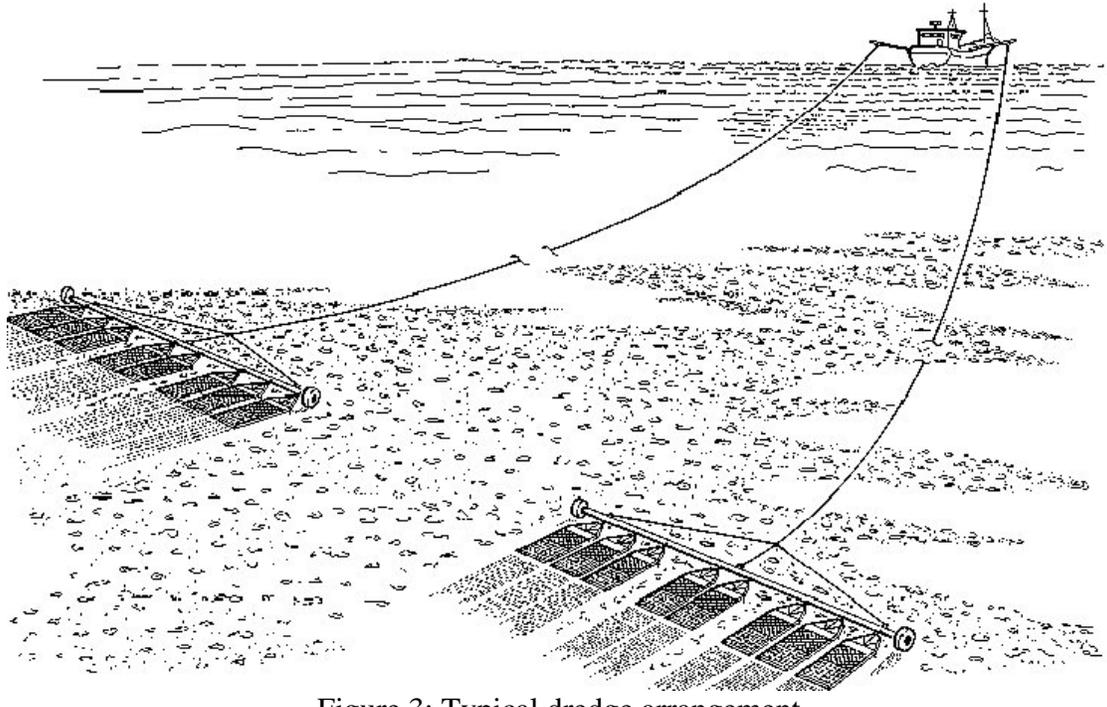
Figure 3: Typical dredge arrangement

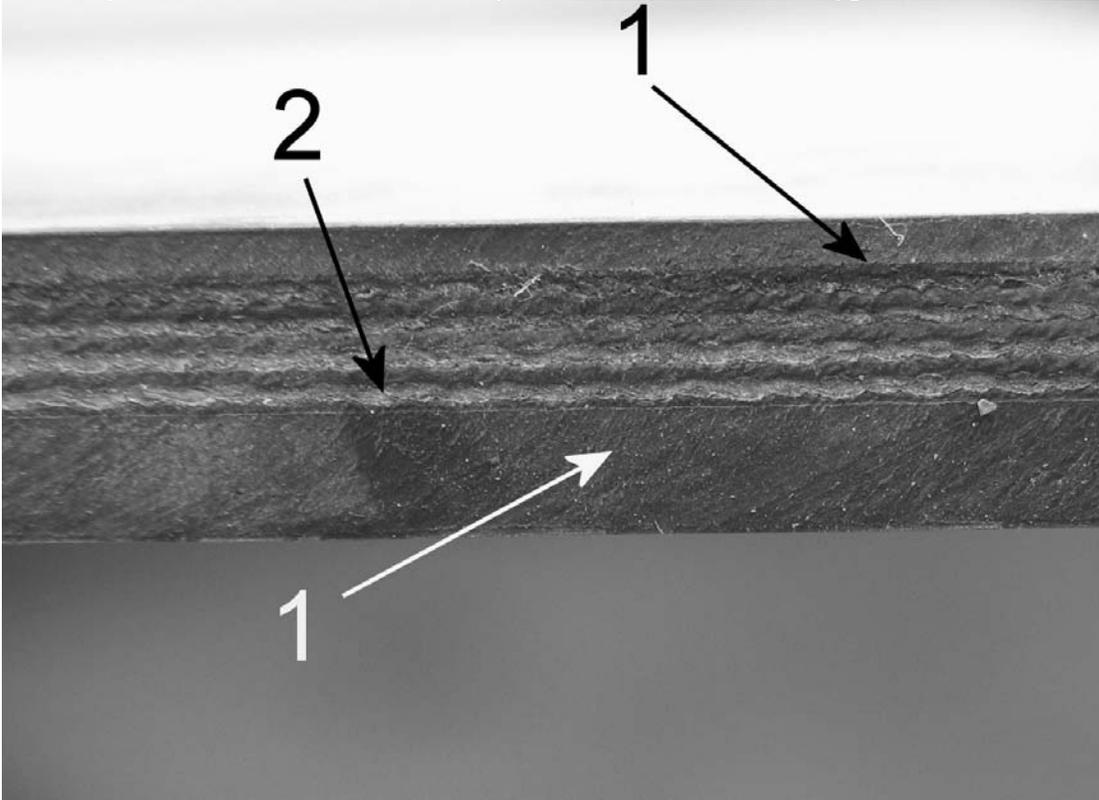
The current design for the front mat uses sections of conveyor belt, cut to size and drilled with mounting holes. The belt is a laminate as shown in Figure 4, consisting of a woven fabric layer (2) bonded between two layers of vulcanised rubber type material (1).

Figure 4: Mat cross section

The mat is quite rigid when new, however, this rigidity lessens as the layers are worn away. As the rigidity reduces, the effectiveness of the mat to flip the scallops into the net also reduces and they start to slip under the mat as it folds further and further back. The mat wears quickly as it was never intended to be used in this application, and as the structure is broken down and the softer fibers become exposed, the wear rate accelerates.

The patterns observed on existing mats indicate very localised wear, mainly on the outer corners. This local wear does however compromise the rigidity of the whole mat in a progressive manner, starting at the outer edges and working toward the centre.

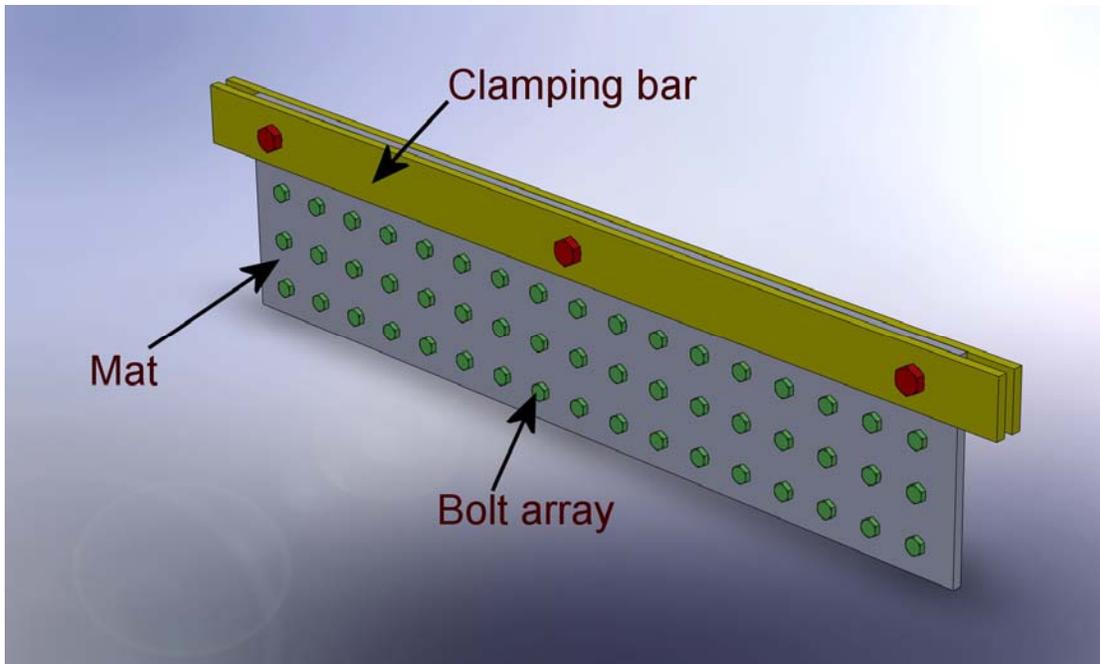
An alternative to a full surface coating is based on the skid pads that were once used on F1 cars. The bottom of the car is relatively fragile and since it is very close to the road, any suspension movement would cause the floor to scrape on the road. As such they used small “door stop” size pads of titanium to protect the floor. A similar principle could be employed with the mats. Titanium, while very hard and tough, is very expensive. An alternative would be standard steel bolts. They are very easy to obtain, very cheap, easy to fit and hence easy to replace and are much harder than vulcanised rubber and since they would be placed at intervals, they would not adversely affect the operational rigidity of the mat. An array of nuts and bolts could be used as shown in Figure 5 (shown in green).

Figure 5: Wear pad arrangement

This will have no impact on the rigidity of the belt but it will protect the surface layers from wear which will prolong the mat life.

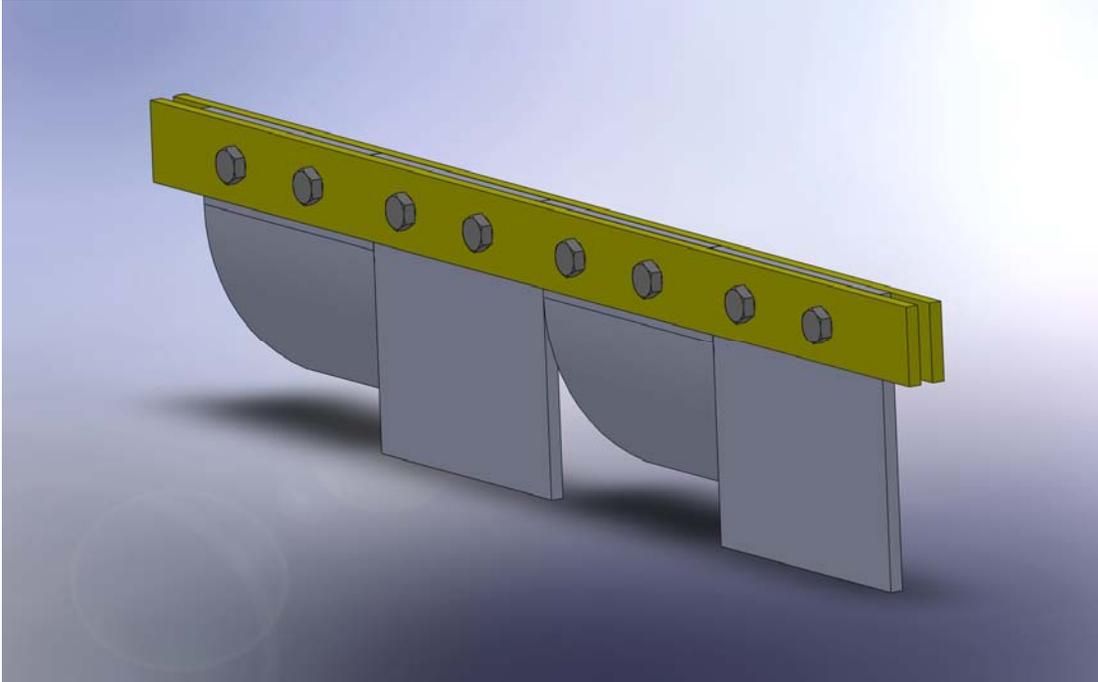
If each area was allowed to flex individually, then each section could ride over the cobbles without affecting adjacent sections. Also large cobbles could be deflected through the gaps between the sections, again reducing the amount of damage these rocks cause. An illustration is shown in Figure 6.

Figure 6: Cut mat arrangement

There is a potential problem with this option. As mentioned above, each area of the mat is pushed down by the surrounding areas and if this is removed by chopping the belt into separate sections, the mat may not be rigid enough to operate effectively. Whether this is a problem or not can only be ascertained by in-situ sea trials. Figure 6 shows the mat cut into four sections though different numbers of sections could be trialed.

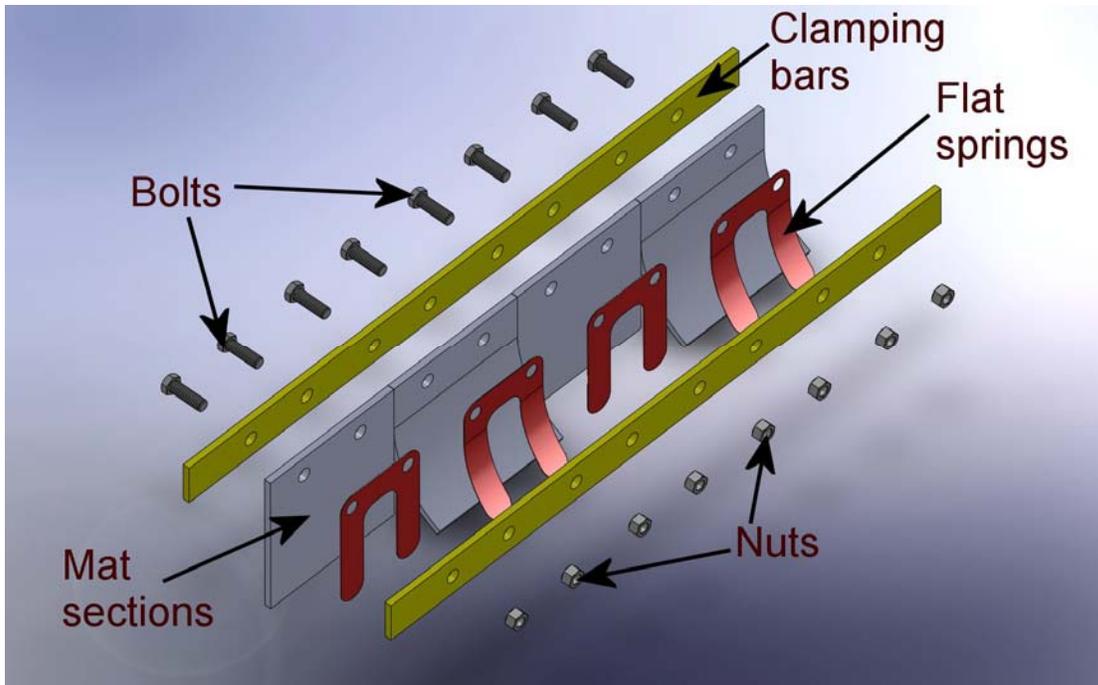
The potential loss in rigidity leads onto a further possible solution. Currently, the mat is a large flat spring. An everyday example of a flat spring can be seen in the form of a measuring ruler. If one end is clamped and a force applied to the free end, as long as the force applied does not exceed the elastic limit of the spring, it will return to its original shape when the force is removed. Although using a flat spring would add complexity to the assembly, it would allow the current mat to be replaced with any flexible hard wearing material and as long as the correct spring was selected, it would mimic the current belt material. Since the structural rigidity would be supplied by the spring and not the mat, the assembly would remain useable until the mat had almost worn through. The cost of the spring would be offset (at least in part) by the use of cheaper matting and the spring cost would be a one off initial outlay. Only the mat would wear out and the spring would not require replacing. As the rigidity is provided by the spring, a sectional approach could be employed without the drawbacks mentioned above. A proposed arrangement is given in Figure 7 (Note: two of the mat sections and associated springs are shown deflected).

Figure 7: Flat spring stiffener arrangement

Obviously, an appropriate spring would need to be discussed with, and probably selected by, the spring supplier. Several manufacturers are given in Appendix B.

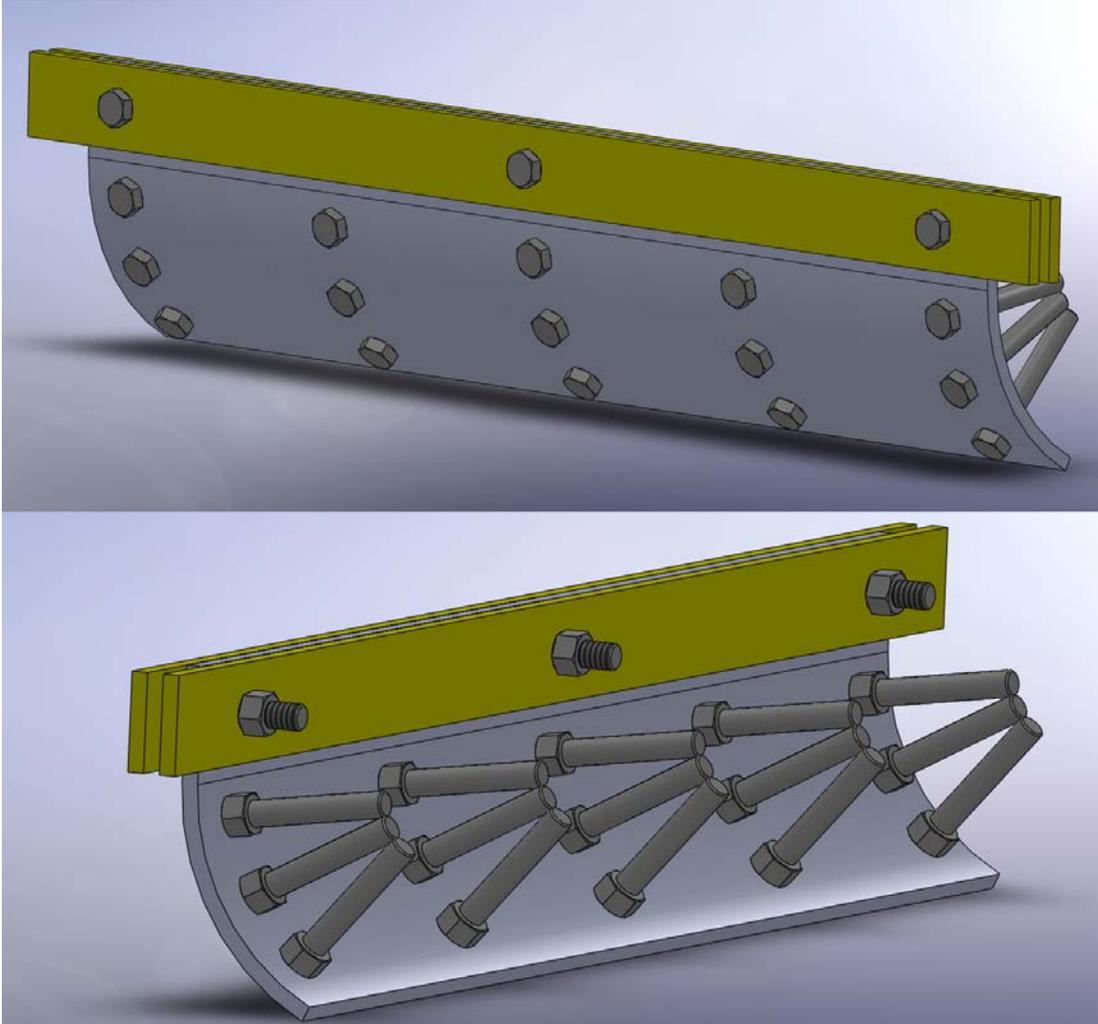
So far it has been assumed that the mat operates effectively due to its flexibility. An alternative is that it is the shape of the mat when under load that creates a “bow wave” which will dislodge the scallops but leave the heavier cobbles still embedded in the sea floor. If this is the case, then an alternative approach can be employed. The shape is dictated by the amount of movement of the bottom of the mat, so by physically limiting the movement of the lower edge of the mat, the correct shape could be achieved using a much less rigid (and hence much cheaper) type of mat. A simple way of doing this would be using a modification to the arrangement shown in Figure 5. By using longer bolts, the ends would restrict the maximum deflection of the mat. This is illustrated by the two views in Figure 8. The bolts used in the illustration are M16 x 110 at a vertical spacing of 50mm (when the mat is flattened) and would give a maximum lateral movement of 82mm. It is unclear if this is the same distance as the mat currently used, however a simple measurement on the dockside would ascertain this and adjustments could be made to the bolt length.

Figure 8: Motion limiting arrangement

This approach is perhaps the easiest to test in sea trials, as it could be employed on existing dredges with very little modification. All that is required is a few nuts and bolts. It could even be employed on worn out mats to see if it rejuvenates their effectiveness. It also has the benefits laid out in the first option discussed above.

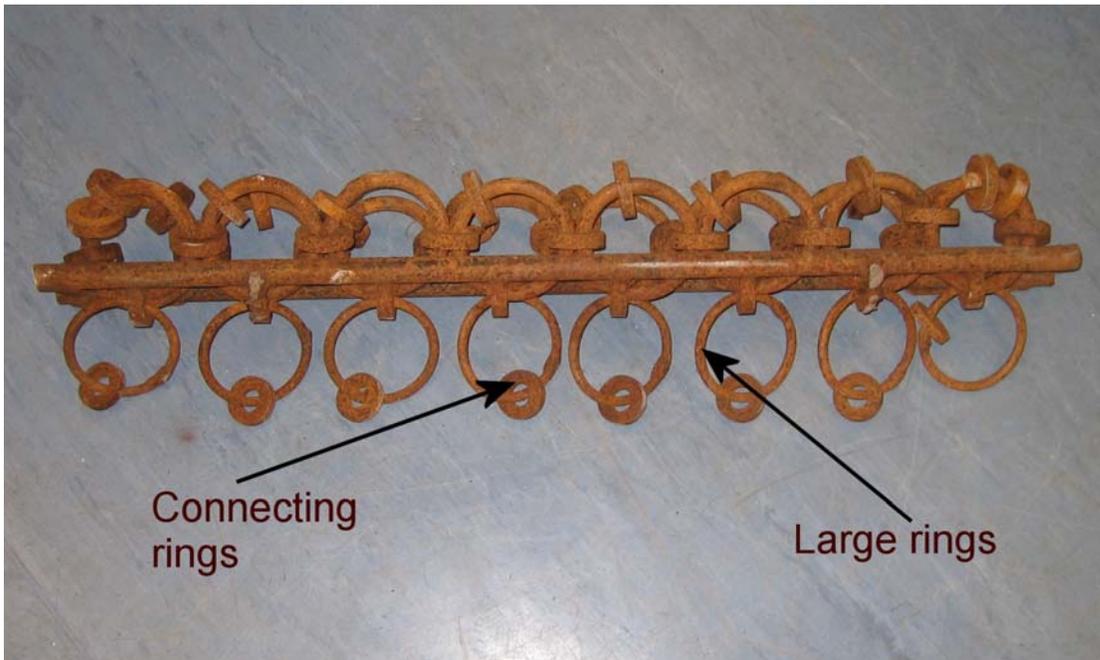
Currently, the net is manufactured in a chainmail style with large metal rings being individually welded around connecting rings. The construction can be seen in Figure 9 which shows one section at the front of the net.

Figure 9: Section of current chain

The net is manufactured from 080M40 (BS 970: 1991) or EN8 (BS970: 1955) which is a medium tensile steel used largely in the automotive industry for axles, spindles etc. but is also used widely in general engineering applications. The material specifications are given in Appendix A. The chain when fabricated, is then case hardened as a complete unit. This immediately brings up two points, both relating to the steel used. Firstly, it is not recommended that steel with a carbon content of above 0.35% is welded unless special precautions are taken (Introduction to Steel Selection Part 1, J. H. E. Fox, 1979, Design Council and BSI). EN8 has a minimum carbon content of 0.36%. This is not a major issue as the carbon content is only just above the recommended value and if the correct preheating (to 100°C using a sulphur free torch) and filler rod (low H<sub>2</sub>) are chosen it can be welded satisfactorily. The second issue is a little more puzzling. EN8 is usually considered a through-hardening steel, whilst case hardening is usually applied to lower carbon steels such as 080M15 (EN32C) for example. Case hardening medium carbon steel (such as EN8) could also alter the properties of the core material. It is possible that the case hardening process is nitriding, which is done at a lower temperature below the

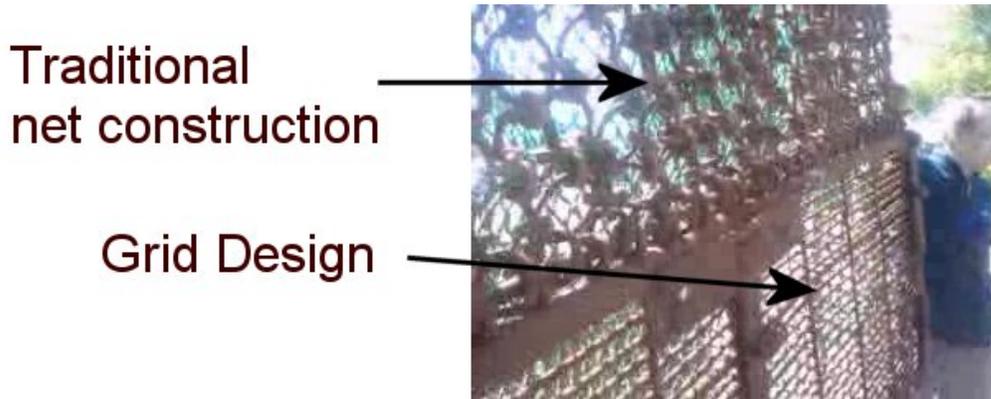
To reduce weight, the basic construction of the net must be changed. WCSP have trialed one method where a section of the net was replaced with a grid. This is shown in Figure 10. The grid has been demonstrated to show several advantages. It is easy to manufacture, each section can be heat treated separately and it can be attached mechanically rather than welded as with the present link system. It also has the advantage of dispersing sand and silt that has collected in the net. Conventional ring type nets collect several hundred kilogrammes of sand and silt during each dredge. A lot of sand slips through the net but a surprising amount stays in which not only has to be towed, but also lifted out of the sea and separated from the scallops on deck. The grid that was trialed had the main bars running laterally which does not allow the sand to escape as well as if they were longitudinally. Also on the trialed arrangement, it was attached using a welded link. If

this were replaced with pinned mechanical joints, then net repair is no longer a specialist job.

Figure 10: Grid modification in situ

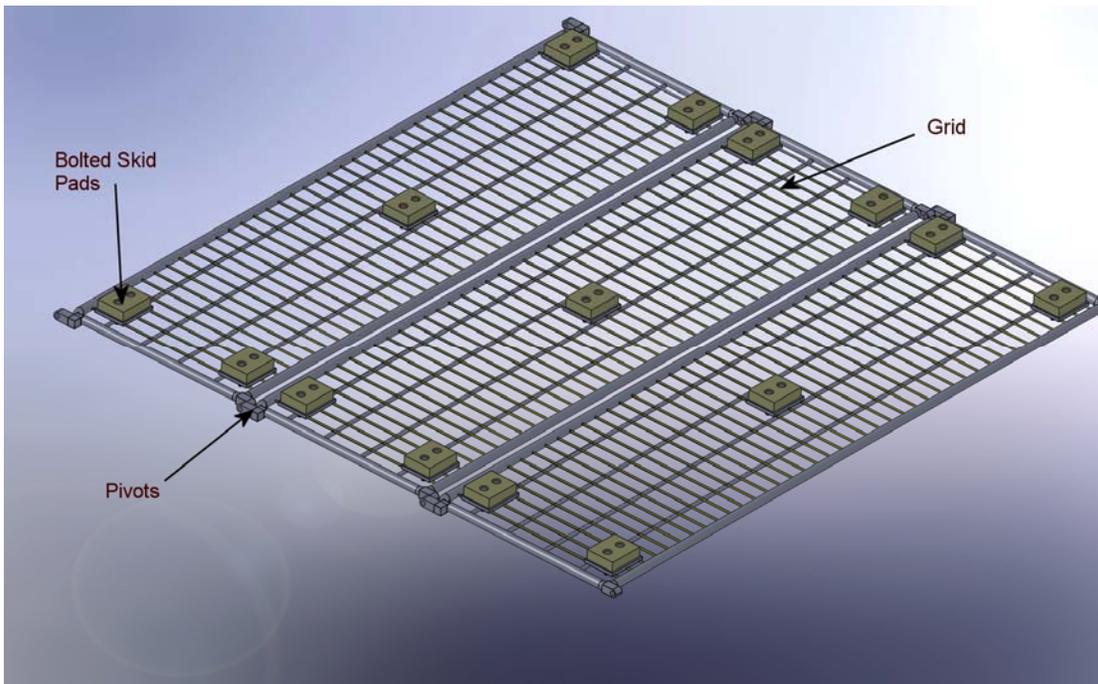
An illustration of a modified grid design is shown in Figure 11. Skid pads could be attached by bolting them on rather than welding, again making maintenance a non-specialist job and as the system would be semi rigid, the number of pads could be reduced when compared to a standard net.

Figure 11: Wear pads bolted to proposed grid

The specific sizes of wire gauge, spacing etc. would need to be determined based on minimum scallop sizes. The larger the gaps between the rods, the more sand, silt and other by-catch will escape. The manufacture of a grid system would be substantially cheaper than the current chain-type design for several reasons. Firstly, the assembly would be fabricated using standard size bar and because it is standard, it is much cheaper

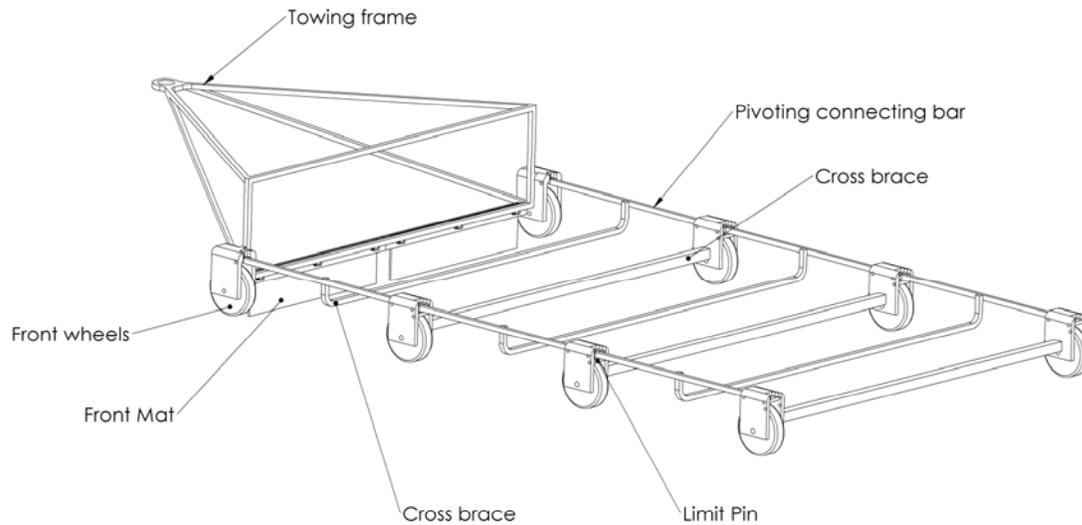
A modification that has already been trialed by WCSP and shown to work on the A-frame is the use of wheels rather than skids. If this idea were extended to the net belly, then apart from two tracks made by the wheels, the only damage to the sea bed would be from the scraper mat which is only surface damage and which will recover quickly (unlike the chain scraper design used by other dredges that scrape below the sea bed causing much more damage). An illustration of this design is shown in Figure 12. Each section is connected with pivoting rods. Limit pins underneath the connecting rods at the trailing edge of the wheel housing stop the wheel housings simply spinning round and dragging along the sea floor but allow a degree of movement to compensate for the uneven sea bed. Slots in the top of the wheel housing allow the net to fold up in sections so the net emptying mechanism on the boat can still work.

Figure 12: Trolley type dredge proposal

Cross braces would not only make the assembly more rigid but also give supports for the net. The net is not shown on the figure 12 for clarity but since it would not contact the sea bed, it could, as stated earlier, be a simple nylon rope net. The pivot mechanism is illustrated in Figure 13 where it shows the ability to move over uneven ground. The last section is shown raised as it would be when being emptied onboard.

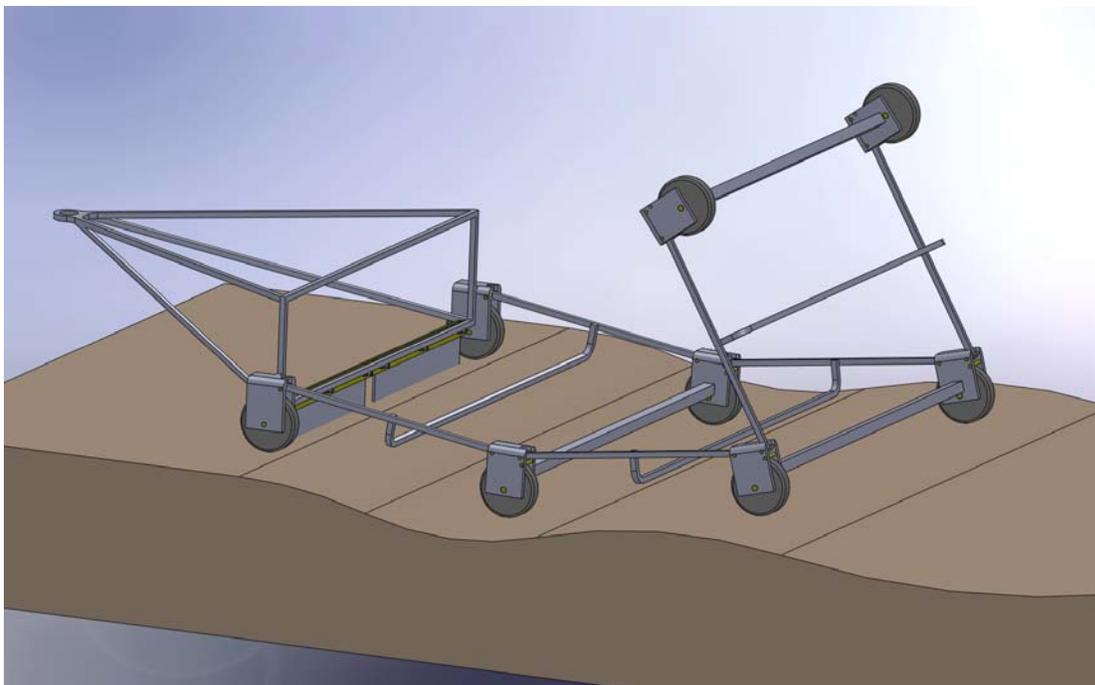
Figure 13: Trolley type dredge un uneven ground

Three sections have been shown for illustration purposes only, but length and number of the connecting bars can be altered to make the assembly more or less flexible as required.

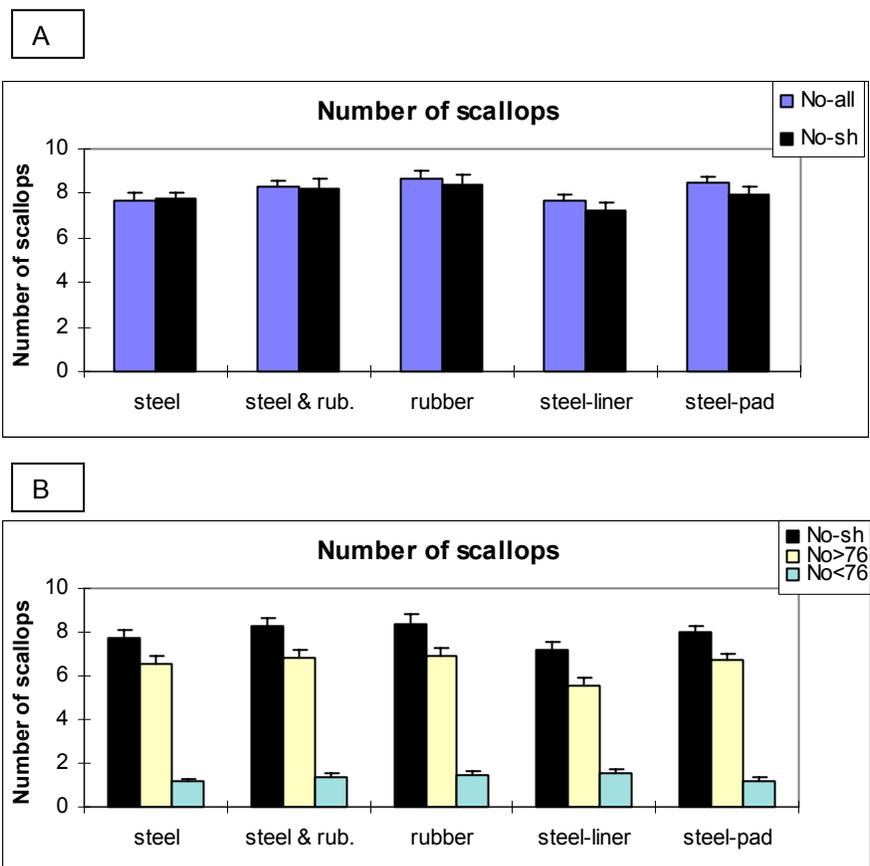
**Figure 2. Number of scallops for (A) all tows and for all measured tows and (B) numbers of scallops for measured tows by size.**

The highest mean number of scallops per tow was found in buckets with two rubber washers followed by the steel-pad and steel and rubber. The lowest count was in the buckets with only steel washers and steel-lined buckets (Figure 2 and Table 2). However, there was no statistical difference between the mean number of scallops per tow and the different bucket types (Table 2).

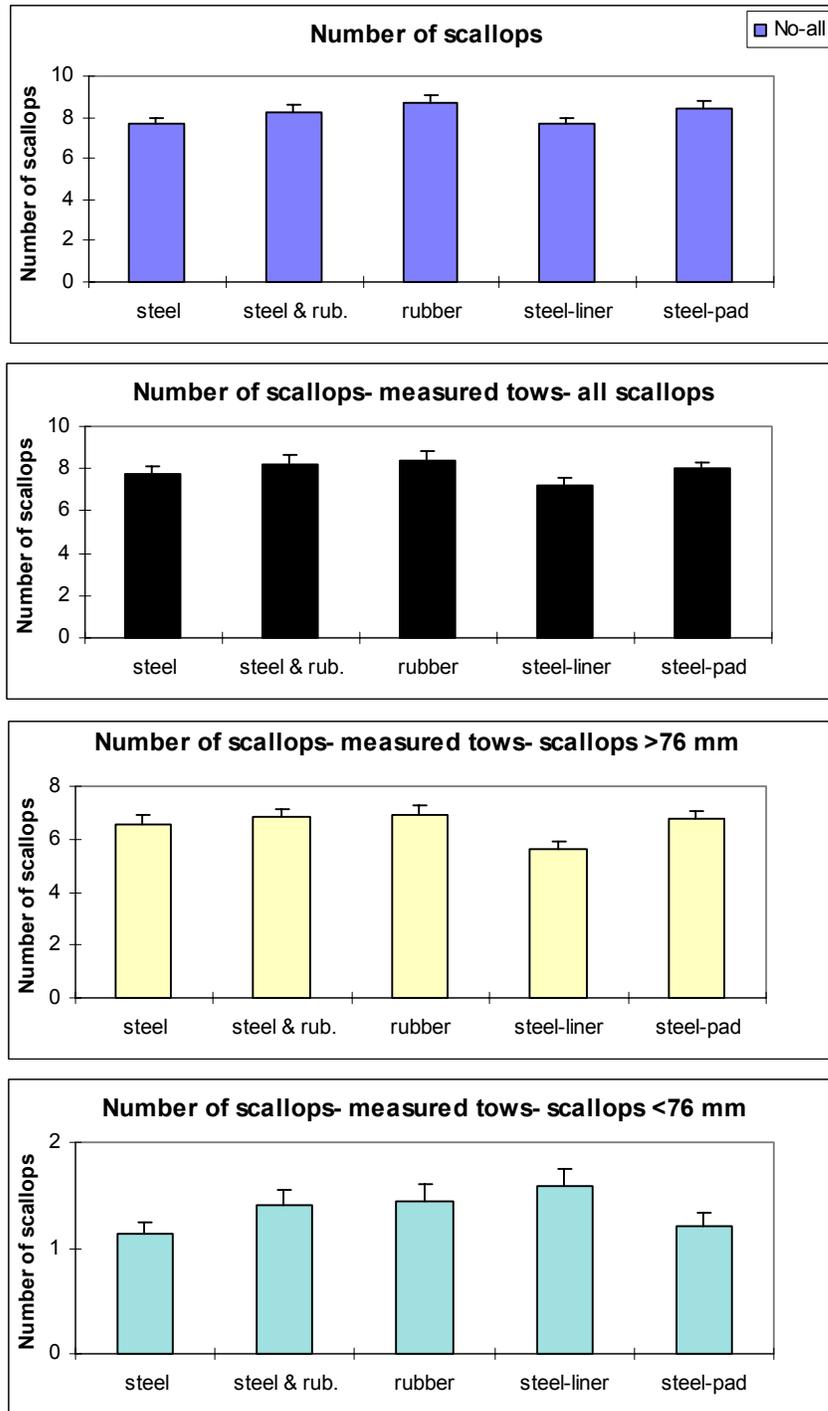
Figure 3. Mean number of scallops for measured tows by scallop size.

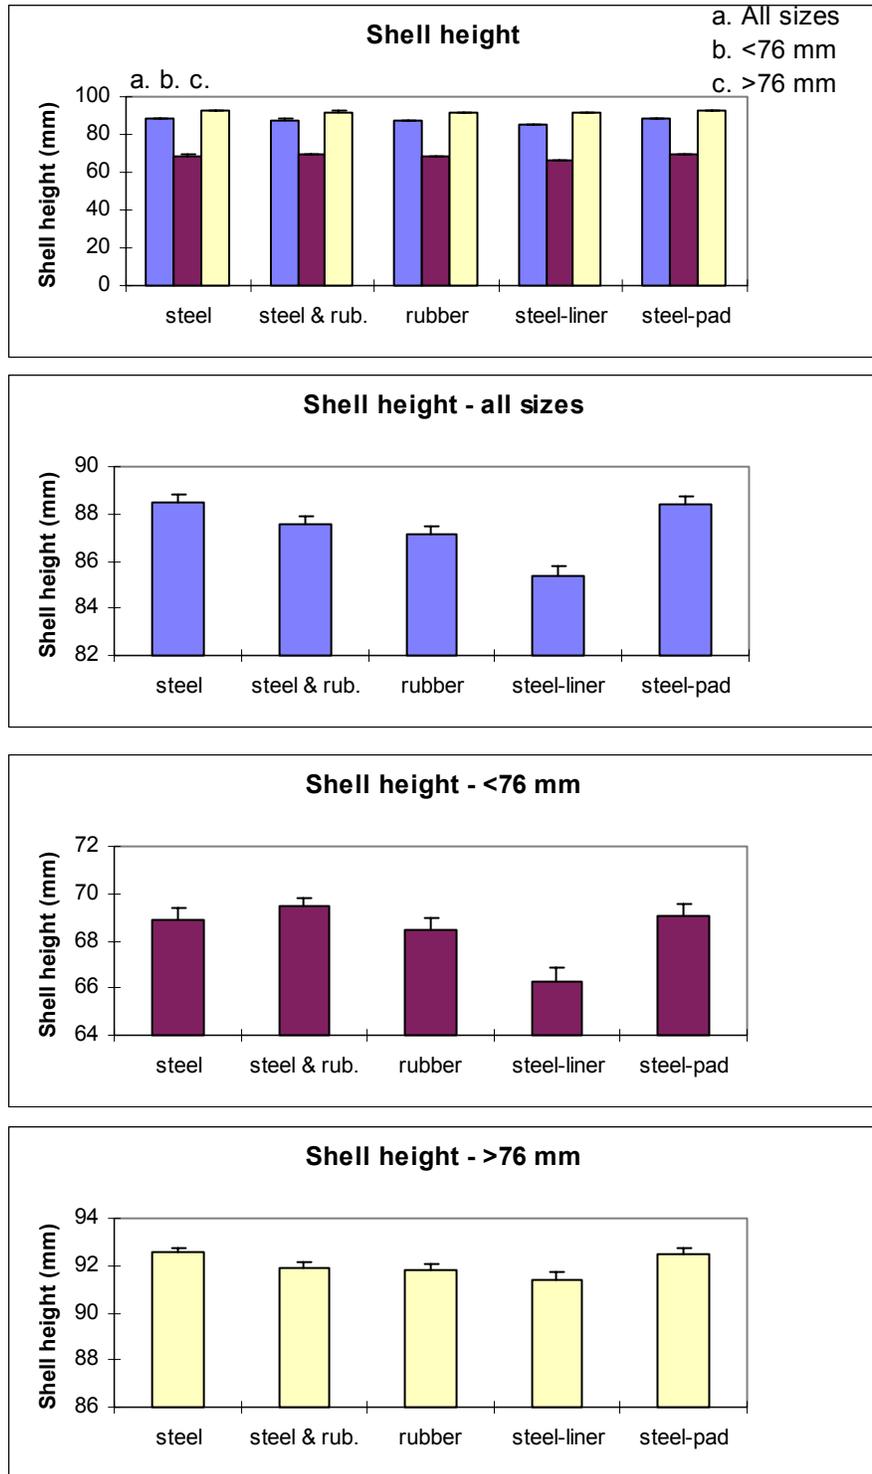
Figure 4. Mean shell height for scallops from measured tows by different scallop size.

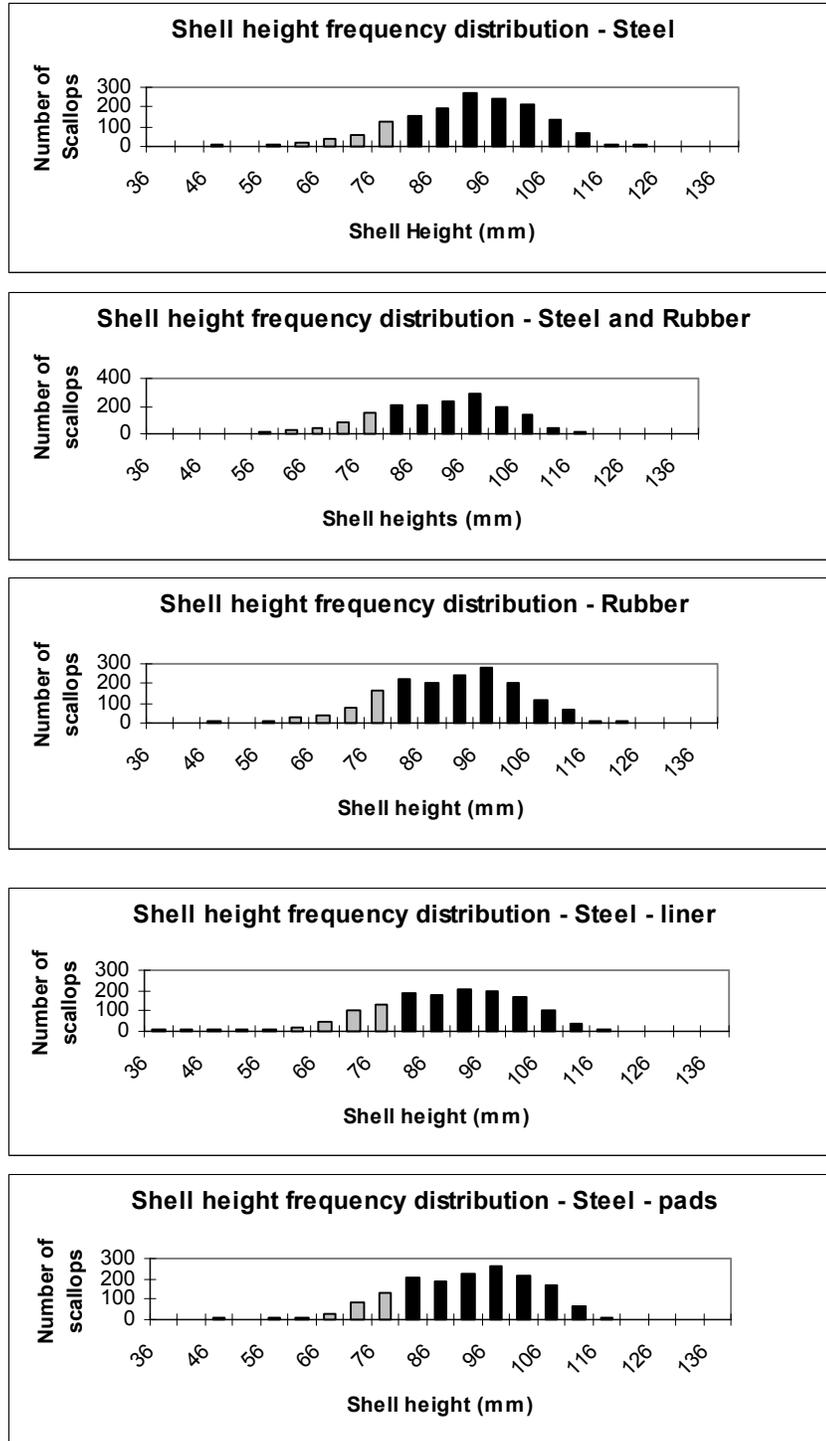
Figure 5. Shell height frequency distribution for all measured tows for each bucket type.

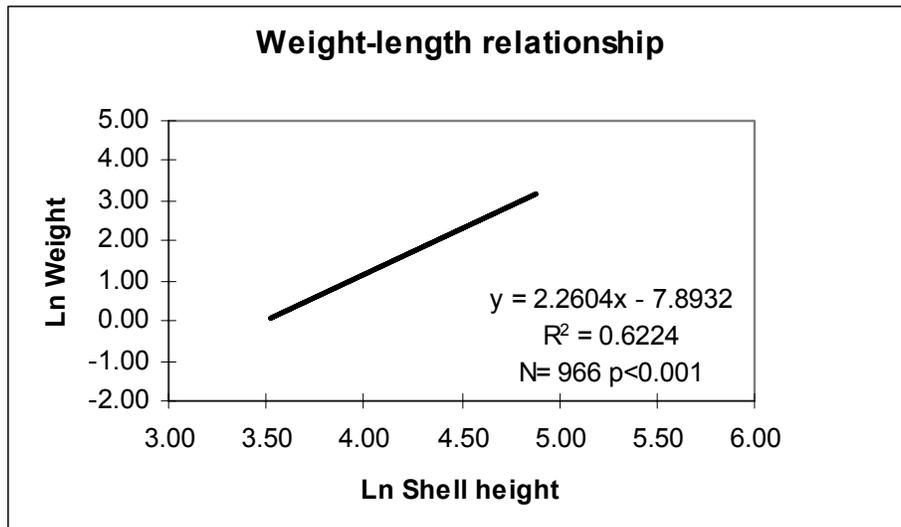
**Figure 6. Weight-length relationship for scallops from Northumberland Strait.**

1. From weight length relationship  $\ln \text{Weight} = 2.2604 \ln \text{Shell Height} - 7.8932$  (Davidson, unpub. data) (Figure 6).

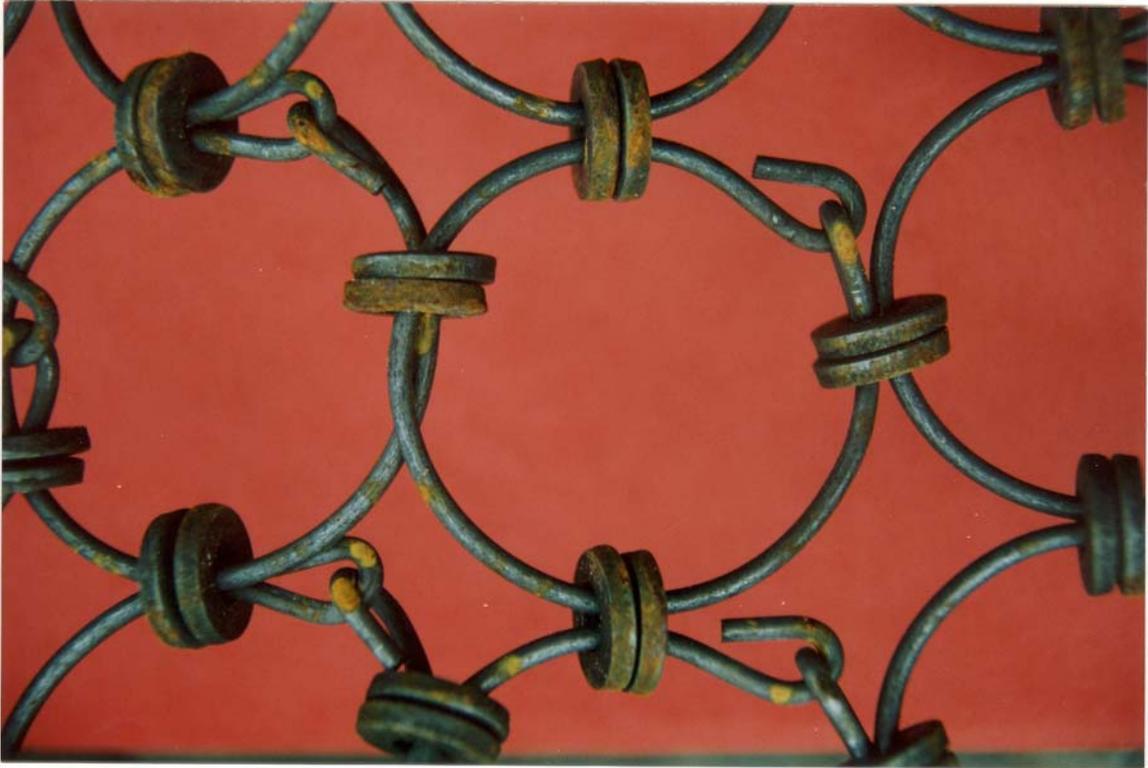
Scallop bucket made with 76 mm (3 inch) rings and steel washers (steel).

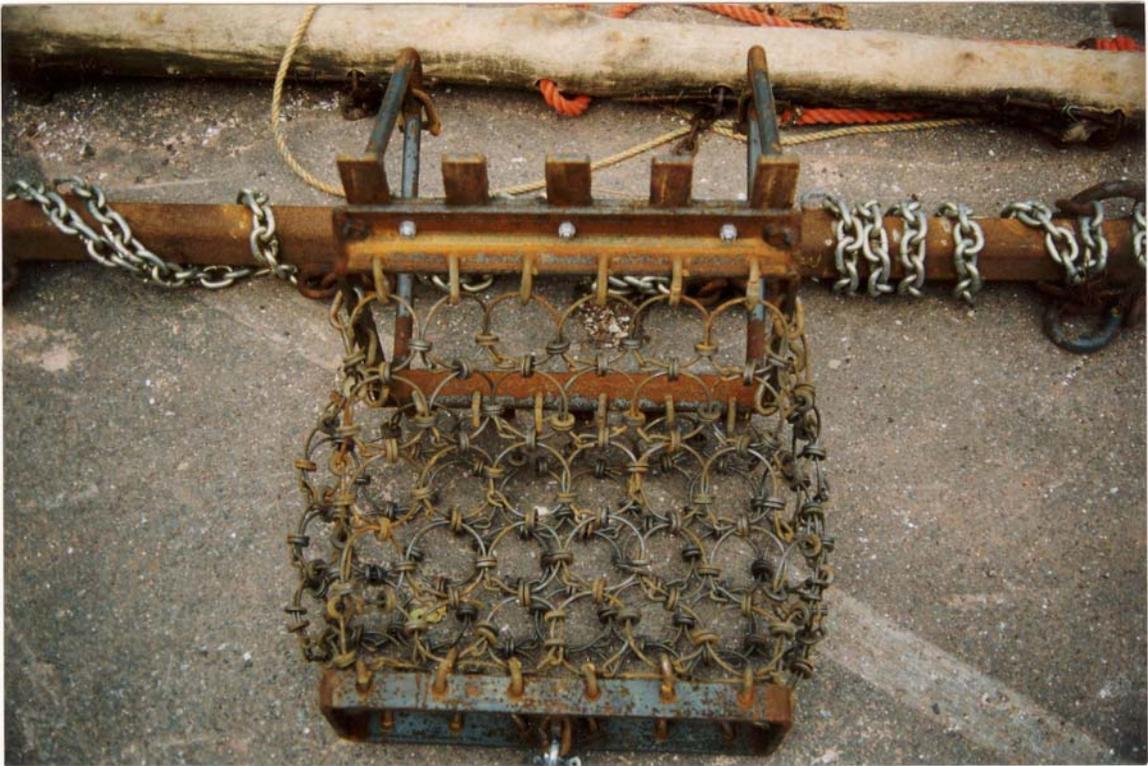
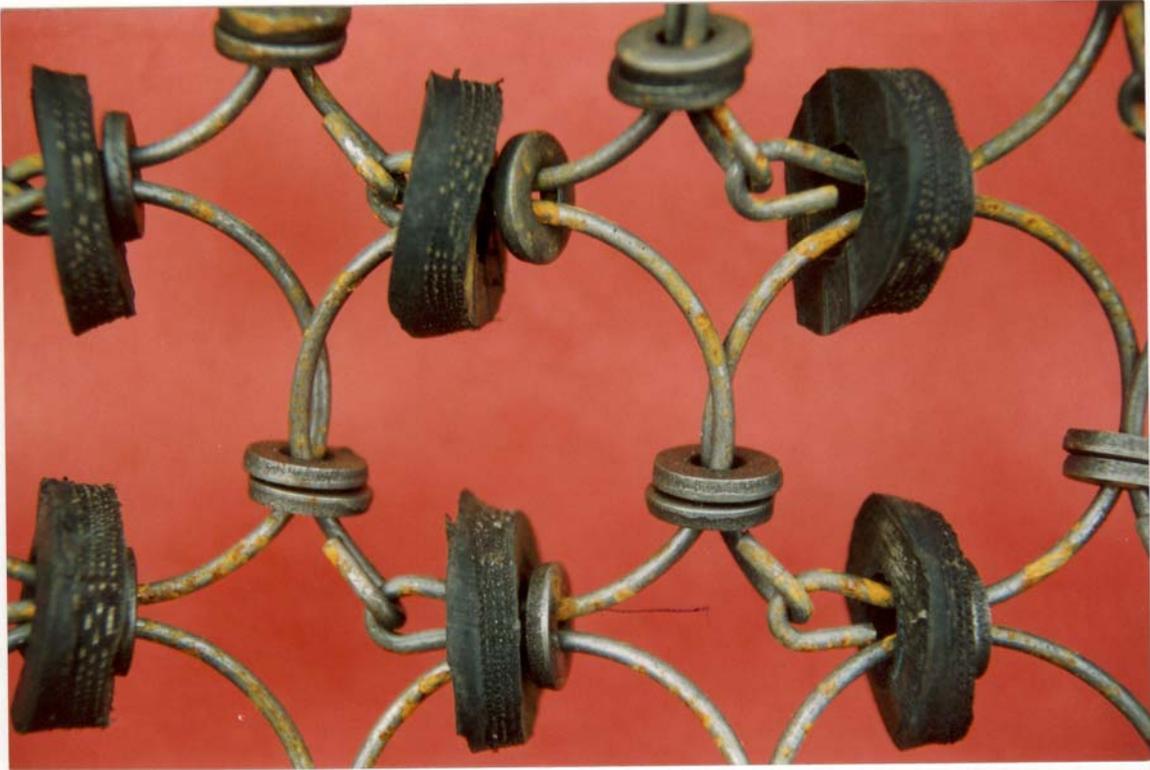
Scallop bucket made with 76 mm (3 inch) rings and steel and rubber washers (rubber and steel).

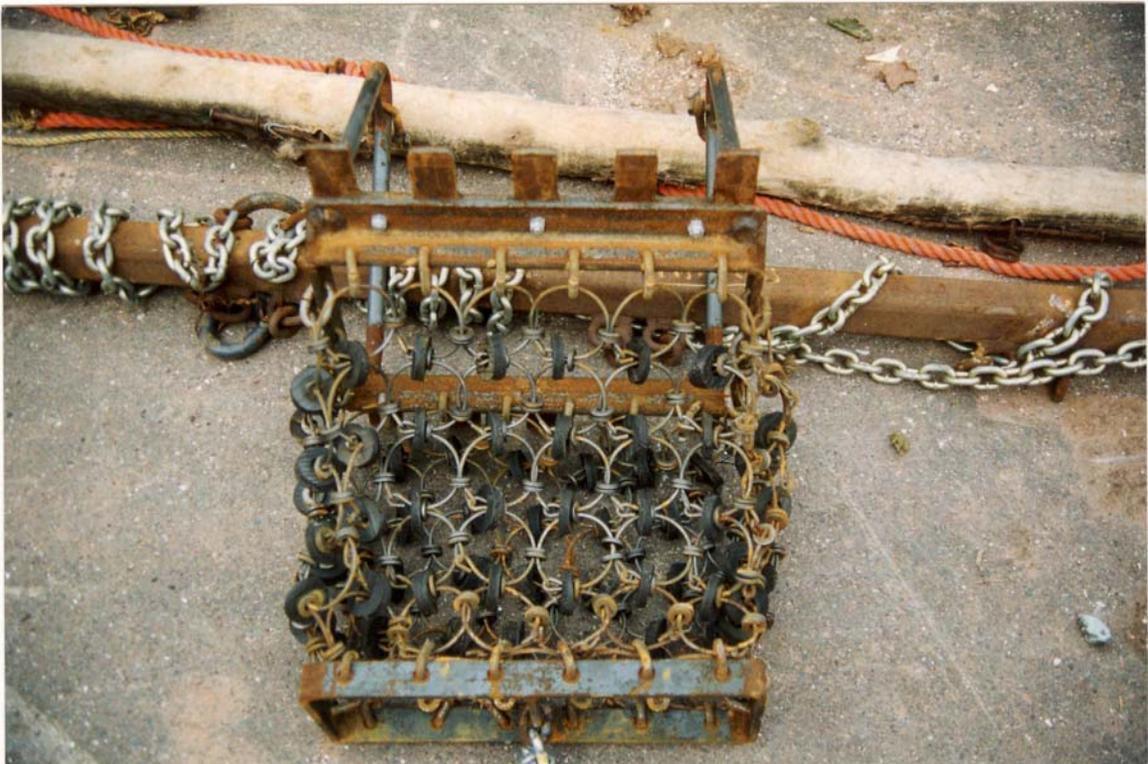
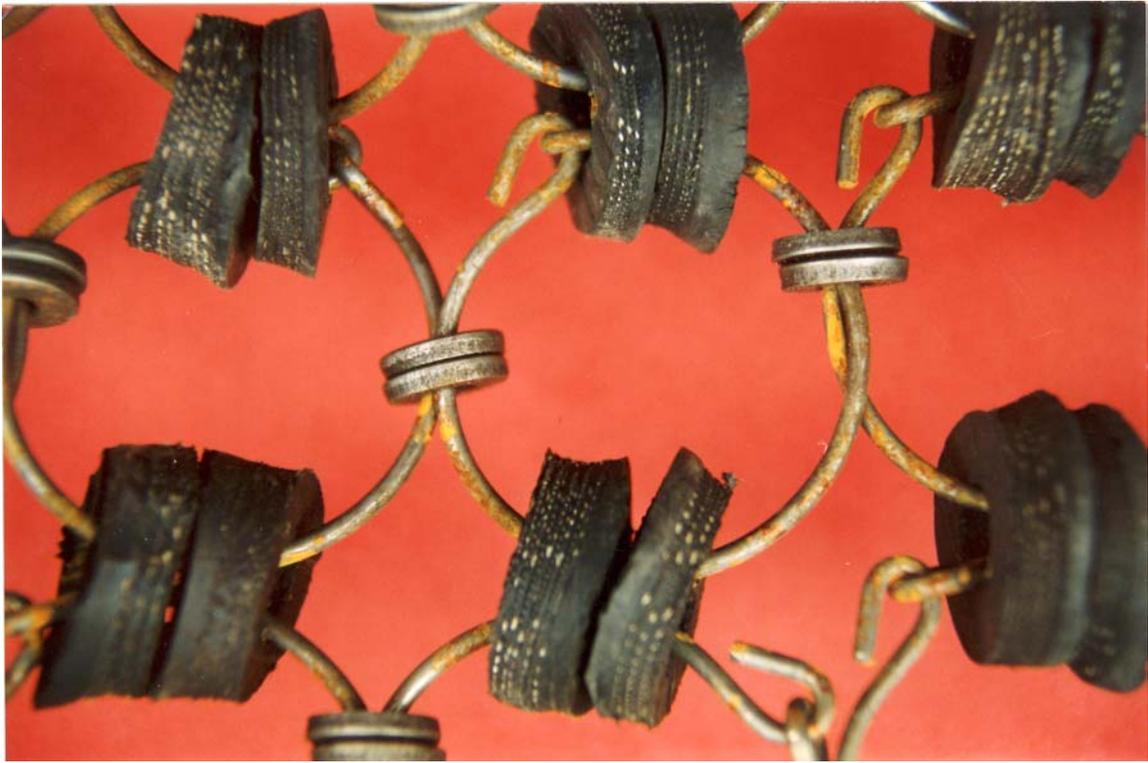
Scallop bucket made with 76 mm (3 inch) rings and rubber washers (rubber).
