# SR613\_Analysis and suggested modifications for Queen Scallop dredge net\_C100

## **West Coast Sea Products Ltd**

# **Analysis and suggested modifications for Queen Scallop dredge net**

**October 2008**

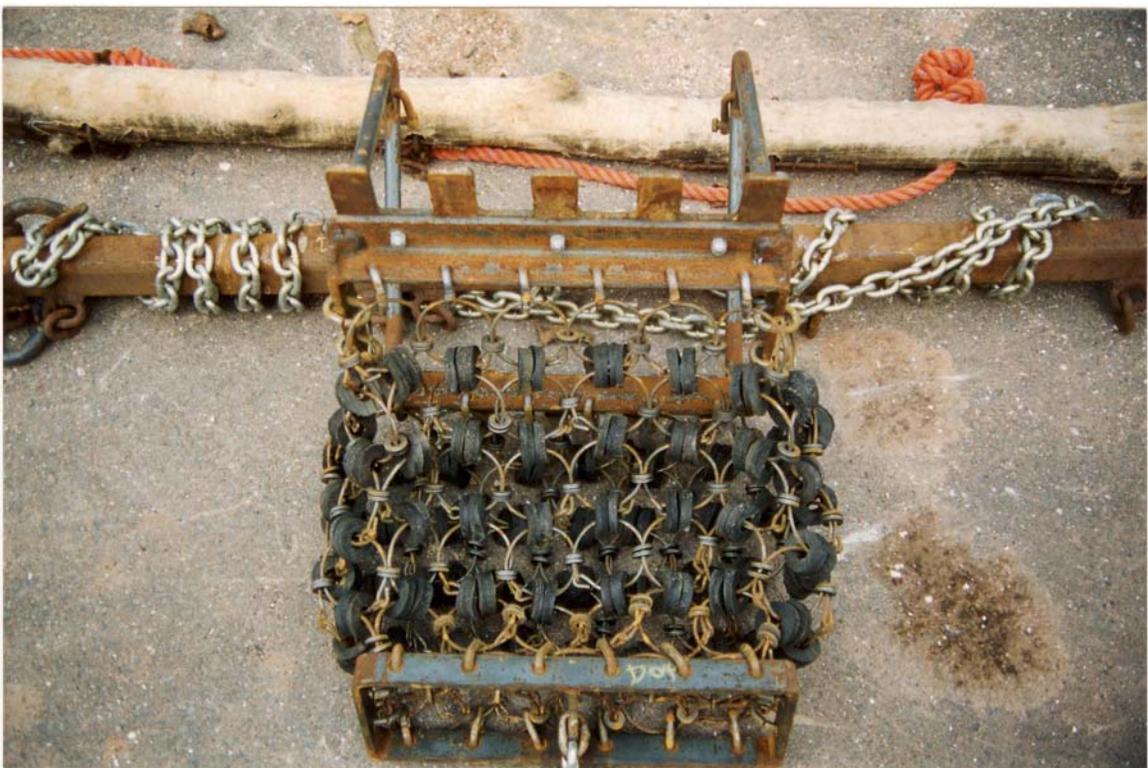
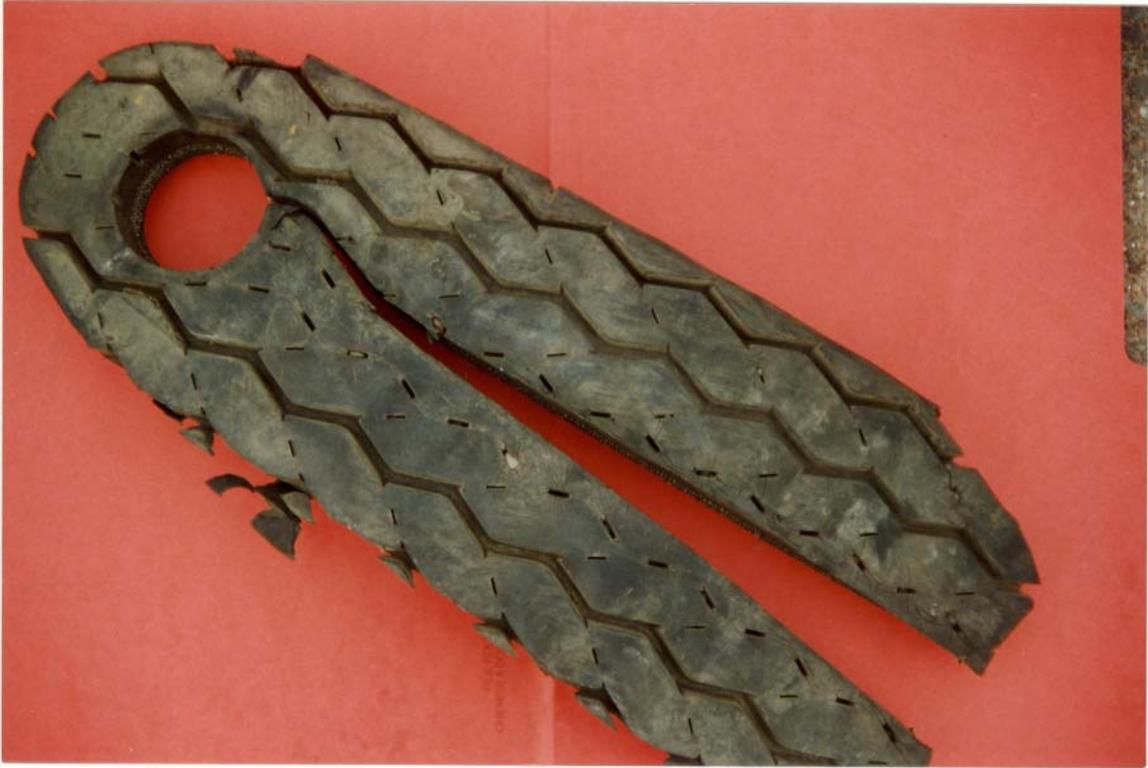
Scallop bucket made with 76 mm (3 inch) rings and steel washers and rubber pads (steel-pad).

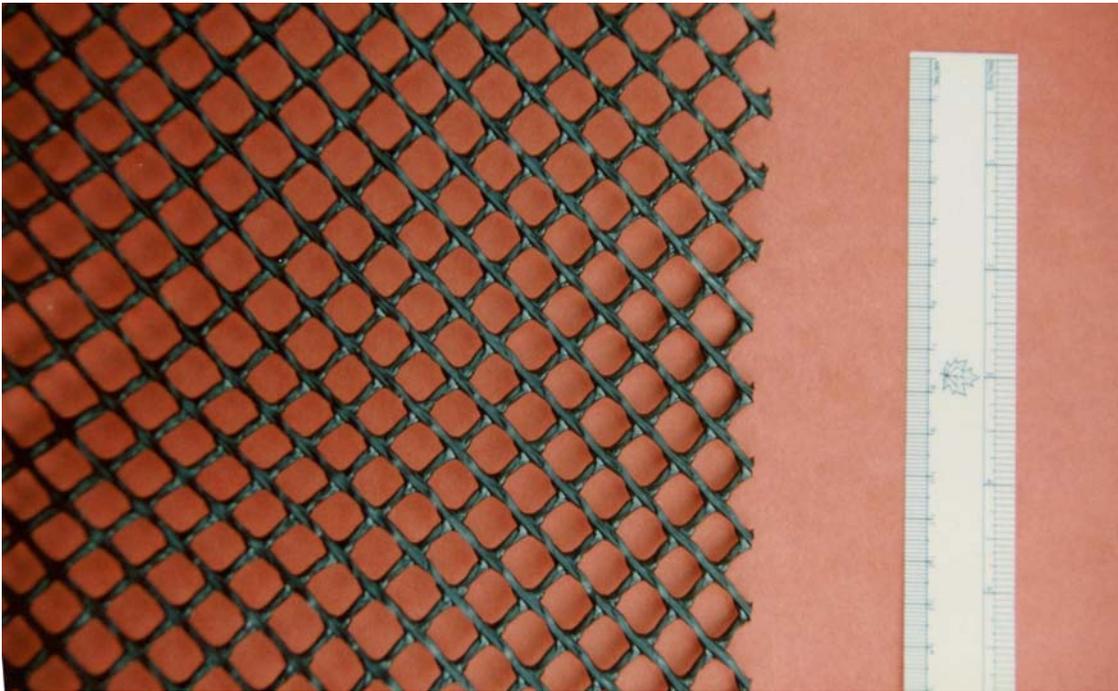
Vexar used to line two buckets made with 76 mm (3 inch) rings and steel washers

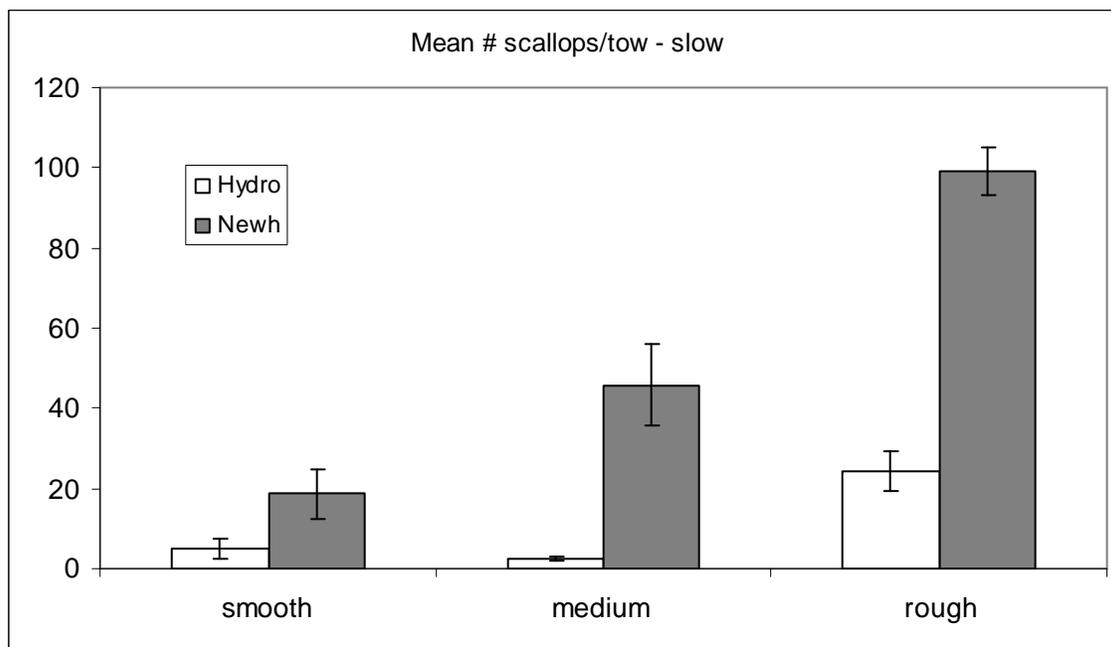
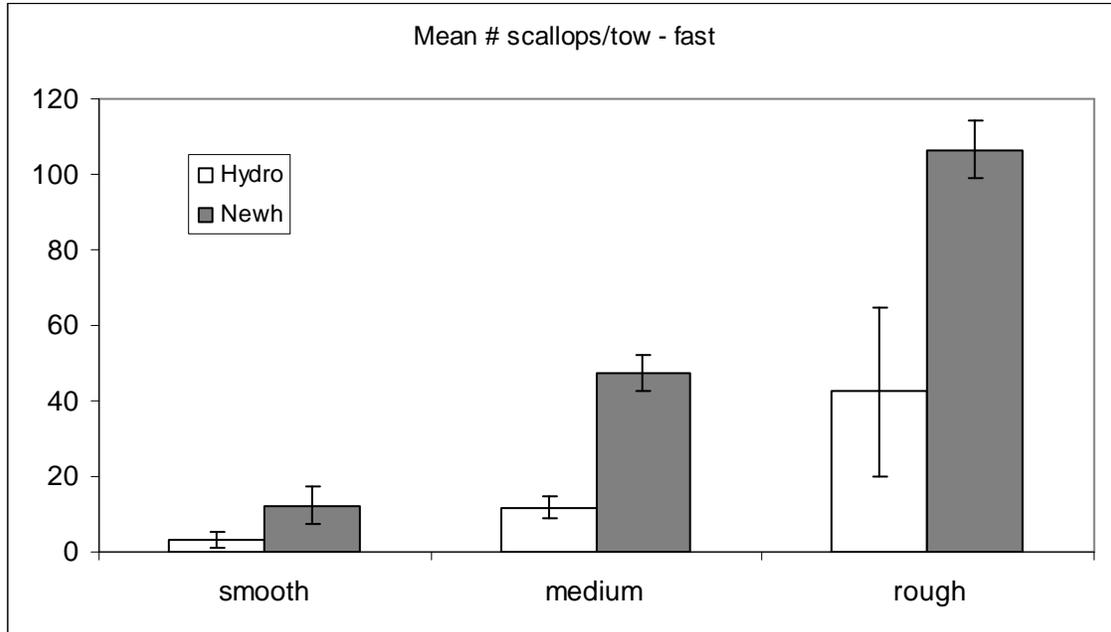
Figure 1. Scallop catch ( $\pm$ SE) in each of Hydro- and Newhaven dredges for three ground types (smooth, medium and hard) at each of slow (2.5kn) and fast (4.0kn) towing speeds.

The Newhaven dredges consistently caught more scallops than the Hydrodredge (Table 1; Fig. 1). There was some interaction between gear and ground (Table 1). A significantly greater percentage of scallops (ANOVA  $F_{1,48} = 18.352, P < 0.0001$ ) in the Newhaven dredges were dead (damage score 4) (Fig. 2) while there was no significant difference in percentage of scallops that had other damage scores. A significantly greater percentage of individuals of bycatch species (ANOVA  $F_{1,47} = 14.028, P < 0.0001$ ) in the Newhaven dredges also were dead (Fig. 3) while there was no significant difference in percentage of bycatch that had other damage scores. These results imply that the tooth-bar on the Newhaven dredge is primarily responsible for the fatal/severe injuries sustained by scallops and bycatch species, while other components of the gear or the catching process account for the less severe physical damage that occurs.

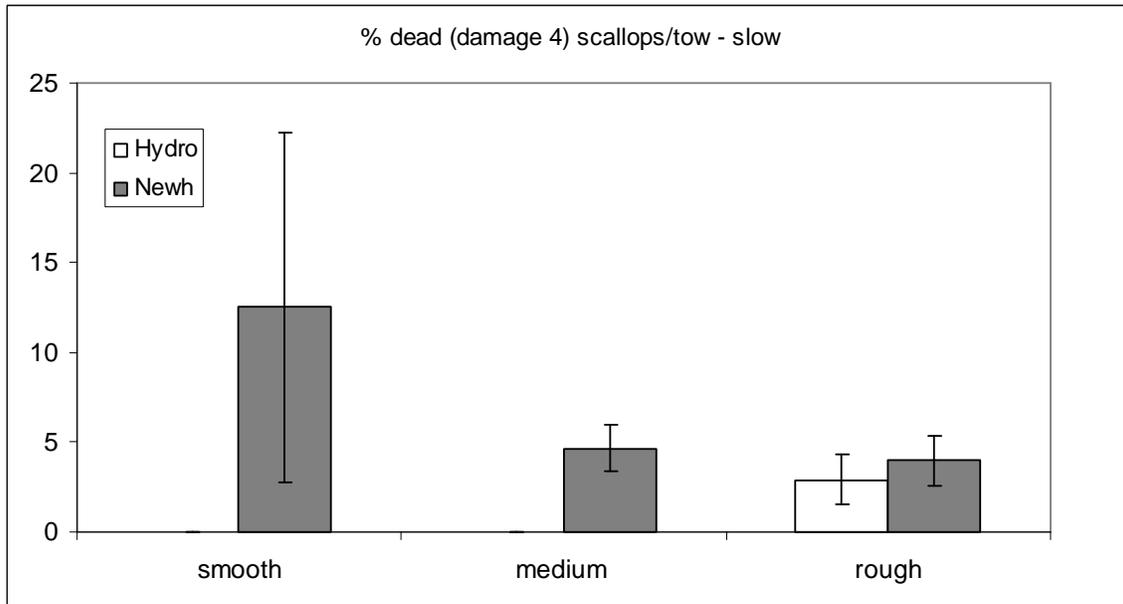
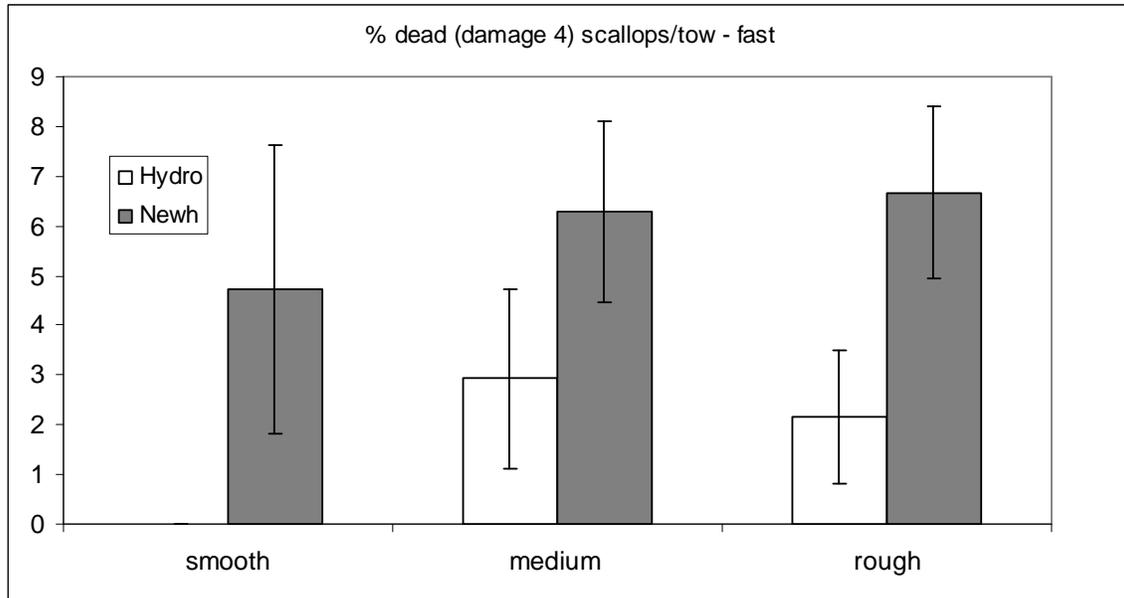
Figure 2. Percentage of scallops ( $\pm$ SE) showing damage score 4 (dead) in each of Hydro- and Newhaven dredges for three ground types (smooth, medium and hard) at each of slow (2.5kn) and fast (4.0kn) speeds.

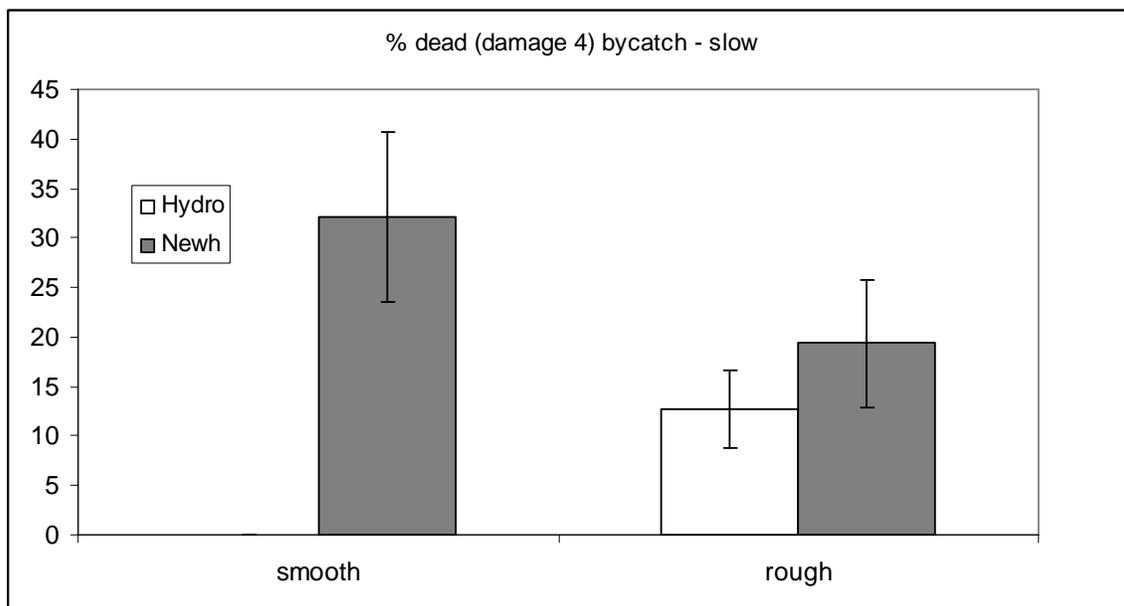
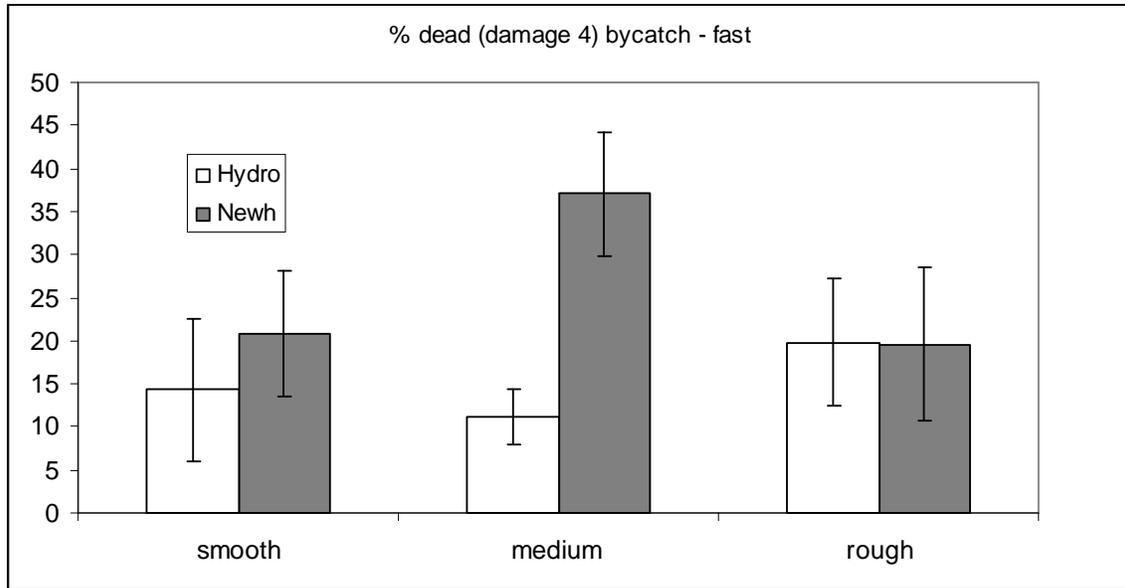
Figure 3. Percentage of bycatch showing damage score 4 (dead) in each of Hydro- and Newhaven dredges for three ground types (smooth, medium and hard) at each of slow (2.5kn) and fast (4.0kn) towing speeds.

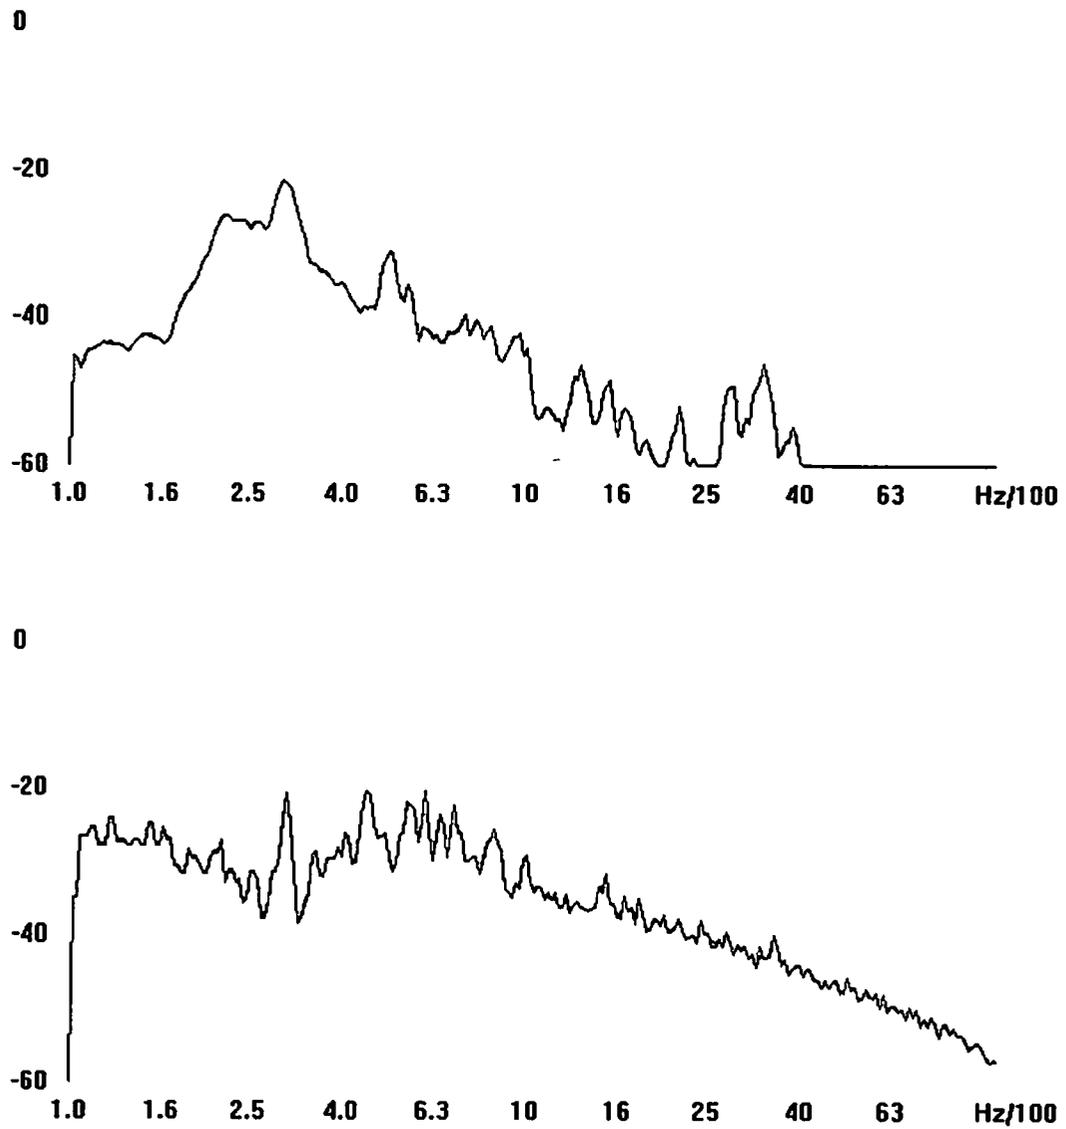
Figure 1: Two sonograms of outboard engine noise: the engine originally observed causing the movement of bay scallops (Seagull, above); and a Mercury outboard recorded opportunistically (below).
